Asbestos Survey for

Codnor Miners Welfare Club

Client Name:	Codnor Miners Welfare Club	Project Number:	S2438
		Survey Date:	07 January 2005
Site Address:	Codnor Miners Welfare Club, Goose Lane, Codnor, Ripley, Derbyshire, DE5 9RG	Printed On:	10 February 2005
		Recommendation:	Page 1 of 3

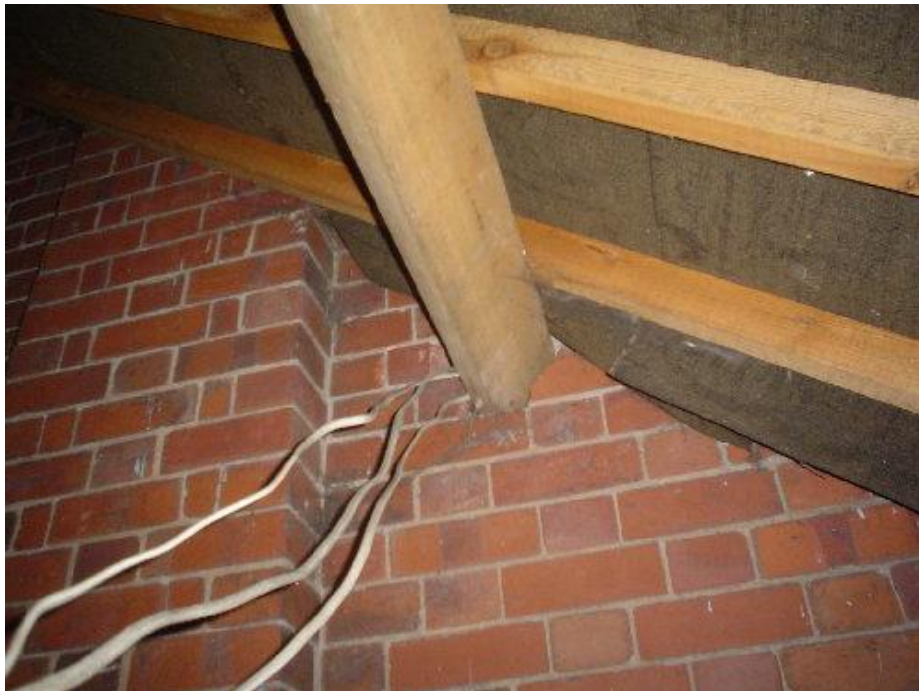
Location ID:	<input type="text" value="1818"/>	Survey Type:	<input type="text" value="T 2"/>
Location Ref:	<input type="text" value="001"/>	Product Type:	<input type="text" value="NADIS"/>
Product:	<input type="text" value="Felt"/>	Damage:	<input type="text" value="NADIS"/>
Area:	<input type="text" value="Main Building"/>	Treatment:	<input type="text" value="NADIS"/>
Floor:	<input type="text" value="Ground floor"/>	Asbestos Type:	<input type="text" value="NADIS"/>
Room:	<input type="text" value="Store 1"/>	Identification:	<input type="text" value="Identified"/>
Surveyor Name:	<input type="text" value="Gavin Curley"/>	Quantity:	<input type="text"/>

Non asbestos felt to roof within ceiling void. Timber joists, brick and breeze walls, MMMF to floor. Non asbestos lino to Store 1 floor, plaster and plasterboard walls and ceiling, timber hatch to roof space.

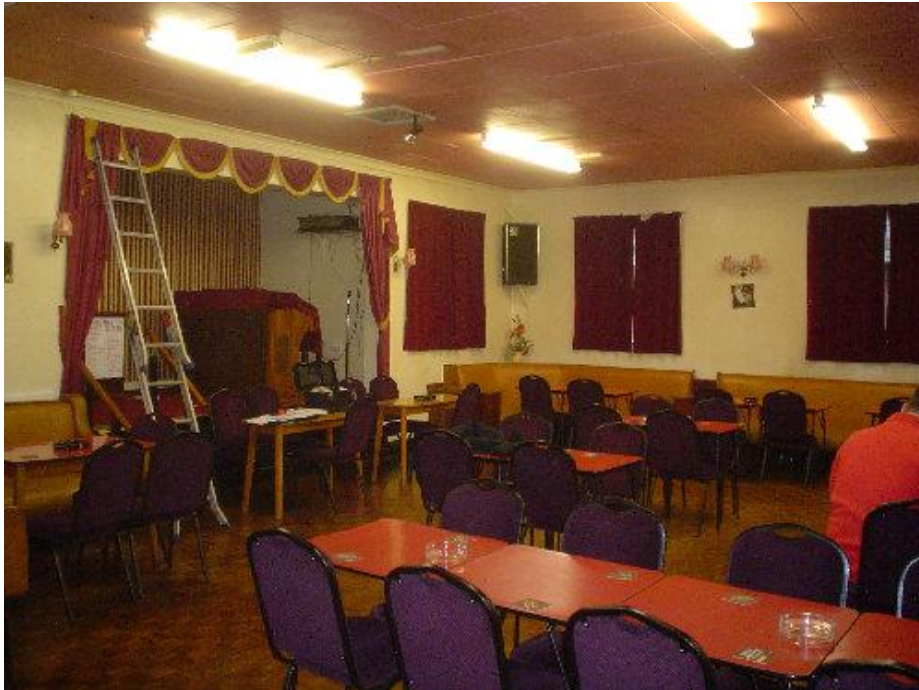
Location ID:	1819	Survey Type:	T 2
Location Ref:	002	Product Type:	Not Applicable
Product:	General view	Damage:	Not Applicable
Area:	Main Building	Treatment:	Not Applicable
Floor:	Ground floor	Asbestos Type:	Not Applicable
Room:	Bar lounge & extension	Identification:	
Surveyor Name:	Gavin Curley	Quantity:	
Drawing Ref:	D01	Accessibility:	
Asbestos ?	No	Material Risk Score	0
Date:	07 January 2005	Material Risk Band:	Not Applicable
Next Inspection:	Not Applicable	Priority Risk Score:	N/A
Analysis:			
Action:	No Action Required

Parquet and carpet floor, carpet to stage, plaster walls, timber boxing to seats with unlagged metal pipework and radiators behind. Fibreboard and plasterboard boxing to top of concertina door, polystyrene tiles to main bar lounge ceiling.

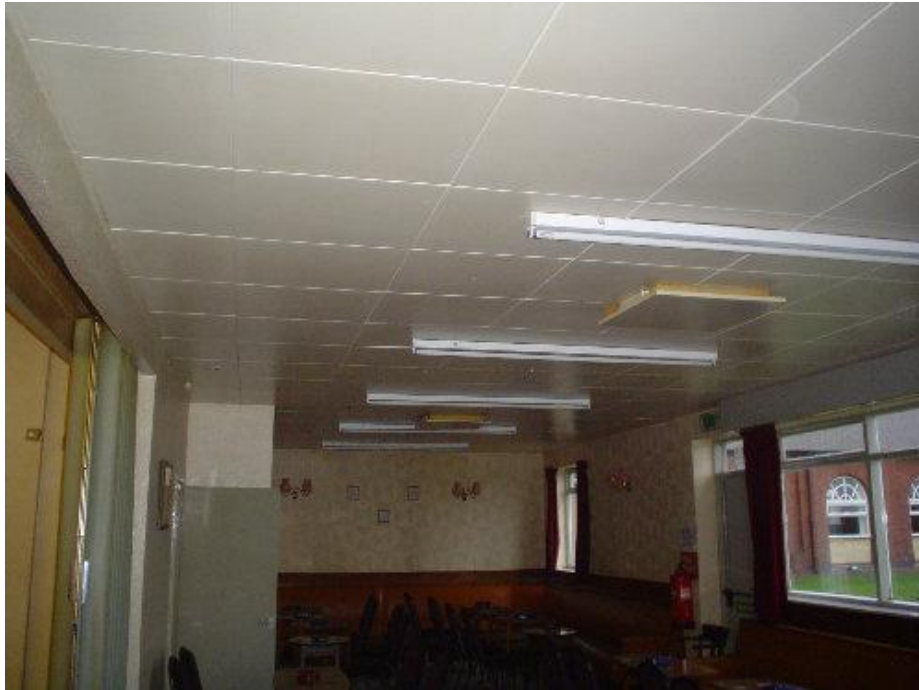
Location ID:	1820	Survey Type:	T 2
Location Ref:	003	Product Type:	NADIS
Product:	Ceiling tile	Damage:	NADIS
Area:	Main Building	Treatment:	NADIS
Floor:	Ground floor	Asbestos Type:	NADIS
Room:	Bar lounge extension	Identification:	Identified
Surveyor Name:	Gavin Curley	Quantity:	
Drawing Ref:	D01	Accessibility:	
Asbestos ?	No	Material Risk Score:	0
Date:	07 January 2005	Material Risk Band:	NADIS
Next Inspection:	Not Applicable	Priority Risk Score:	N/A
Analysis:			
Action:	No Action Required

Non asbestos ceiling tiles. No access possible above.

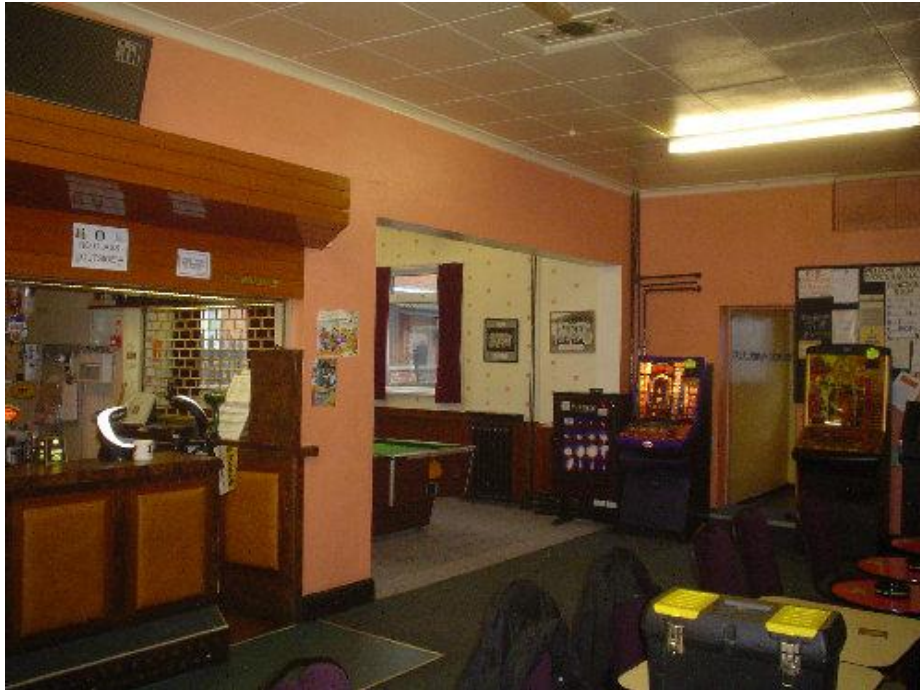
Location ID:	1821	Survey Type:	T 2
Location Ref:	004	Product Type:	Not Applicable
Product:	General view	Damage:	Not Applicable
Area:	Main Building	Treatment:	Not Applicable
Floor:	Ground floor	Asbestos Type:	Not Applicable
Room:	Outer bar	Identification:	
Surveyor Name:	Gavin Curley	Quantity:	
Drawing Ref:	D01	Accessibility:	
Asbestos ?	No	Material Risk Score	0
Date:	07 January 2005	Material Risk Band:	Not Applicable
Next Inspection:	Not Applicable	Priority Risk Score:	N/A
Analysis:			
Action:	No Action Required

Carpet and non asbestos lino to floor, polystyrene ceiling tiles, plaster walls, timber cladding to walls around pool table, plastic coating cladding and leather panels to bar.

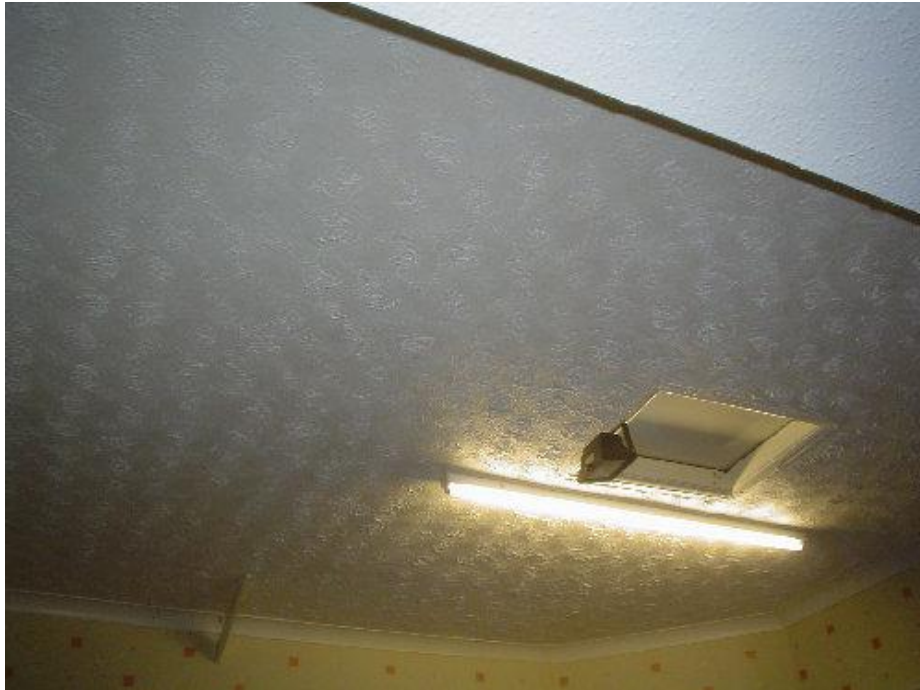
Location ID:	1822	Survey Type:	T 2
Location Ref:	005	Product Type:	NADIS
Product:	Textured coating	Damage:	NADIS
Area:	Main Building	Treatment:	NADIS
Floor:	Ground floor	Asbestos Type:	NADIS
Room:	Outer bar	Identification:	Identified
Surveyor Name:	Gavin Curley	Quantity:	
Drawing Ref:	D01	Accessibility:	
Asbestos ?	No	Material Risk Score:	0
Date:	07 January 2005	Material Risk Band:	NADIS
Next Inspection:	Not Applicable	Priority Risk Score:	N/A
Analysis:			
Action:	No Action Required

Non asbestos textured coating to ceiling over pool table.

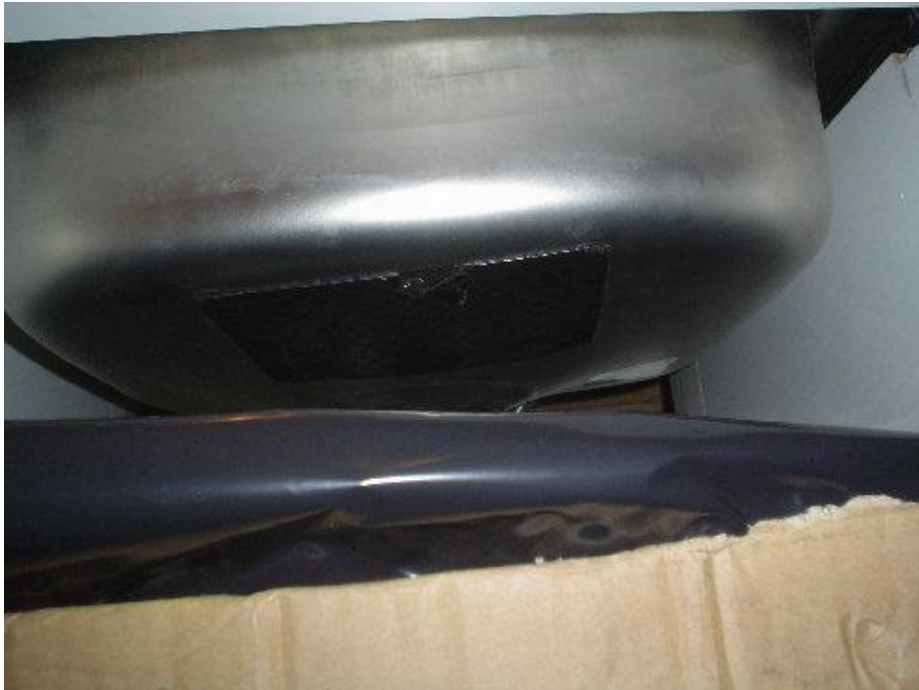
Location ID:	1823	Survey Type:	T 2
Location Ref:	006	Product Type:	NADIS
Product:	Bitumen pad	Damage:	NADIS
Area:	Main Building	Treatment:	NADIS
Floor:	Ground floor	Asbestos Type:	NADIS
Room:	Bar 1	Identification:	Identified
Surveyor Name:	Gavin Curley	Quantity:	
Drawing Ref:	D01	Accessibility:	
Asbestos ?	No	Material Risk Score:	0
Date:	07 January 2005	Material Risk Band:	NADIS
Next Inspection:	Not Applicable	Priority Risk Score:	N/A
Analysis:			
Action:	No Action Required

Non asbestos bitumen pad to sink unit. Non asbestos lino to floor, plaster, plasterboard and timber walls, non asbestos suspended ceiling tiles over serving counter area. No access was possible above these ceiling tiles.

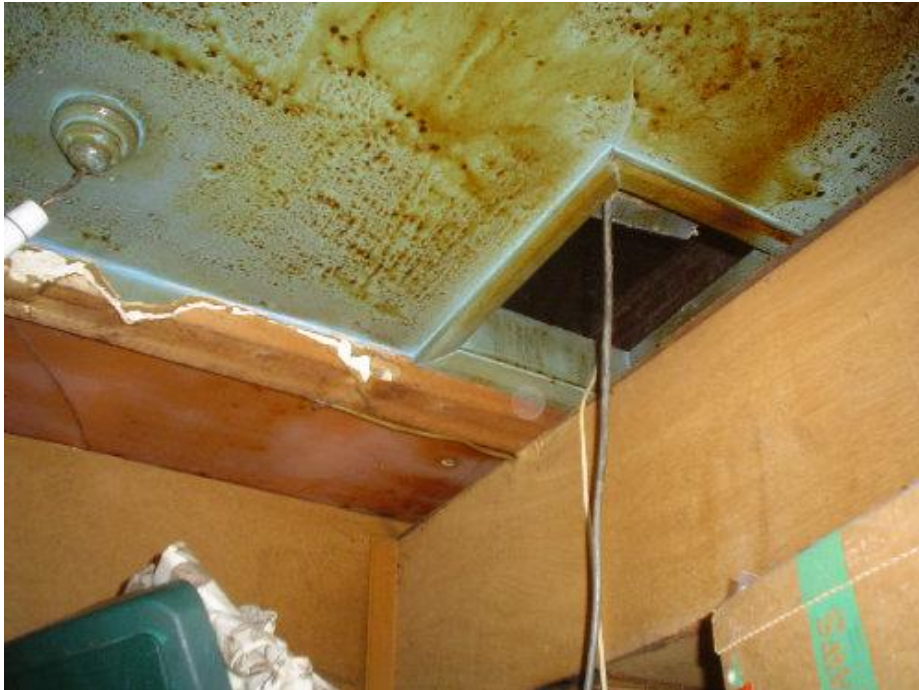
Location ID:	1824	Survey Type:	T 2
Location Ref:	007	Product Type:	Not Applicable
Product:	General view	Damage:	Not Applicable
Area:	Main Building	Treatment:	Not Applicable
Floor:	Ground floor	Asbestos Type:	Not Applicable
Room:	Bar 1	Identification:	
Surveyor Name:	Gavin Curley	Quantity:	
Drawing Ref:	D01	Accessibility:	
Asbestos ?	No	Material Risk Score:	0
Date:	07 January 2005	Material Risk Band:	Not Applicable
Next Inspection:	Not Applicable	Priority Risk Score:	N/A
Analysis:			
Action:	No Action Required

Plasterboard ceiling to rear with timber access hatch to plaster and plasterboard ceiling, chipboard to floor. Limited view due to stored items. No access up to larger roof space observed through hatch.

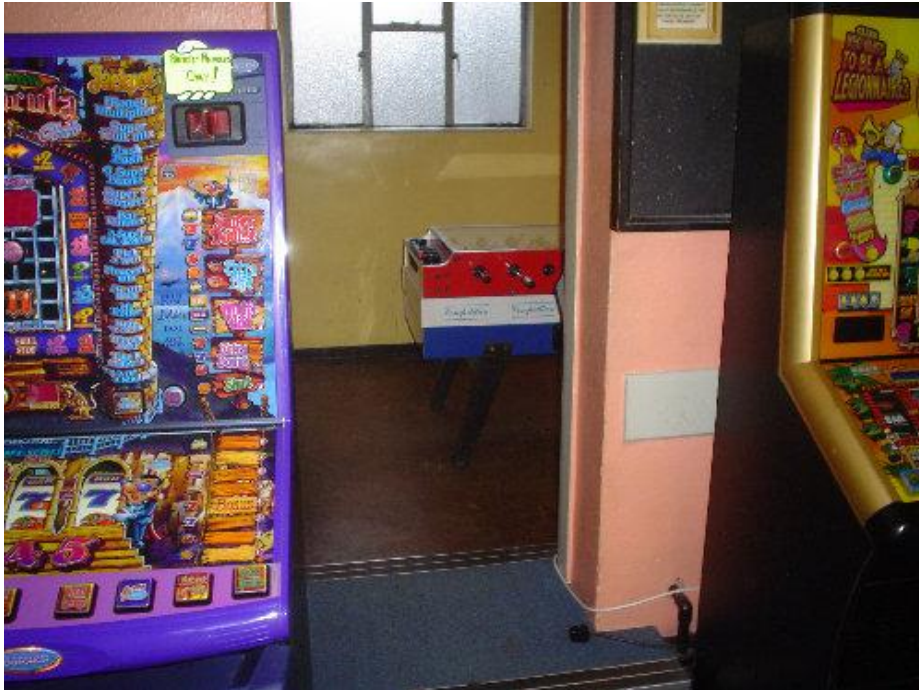
Location ID:	1825	Survey Type:	T 2
Location Ref:	008	Product Type:	Not Applicable
Product:	General view	Damage:	Not Applicable
Area:	Main Building	Treatment:	Not Applicable
Floor:	Ground floor	Asbestos Type:	Not Applicable
Room:	Games room	Identification:	
Surveyor Name:	Gavin Curley	Quantity:	
Drawing Ref:	D01	Accessibility:	
Asbestos ?	No	Material Risk Score	0
Date:	07 January 2005	Material Risk Band:	Not Applicable
Next Inspection:	Not Applicable	Priority Risk Score:	N/A
Analysis:			
Action:	No Action Required

Plaster and fibreboard walls, plaster and plasterboard ceiling, parquet floor, unlagged metal pipework, rubber tread edging to step in doorway.

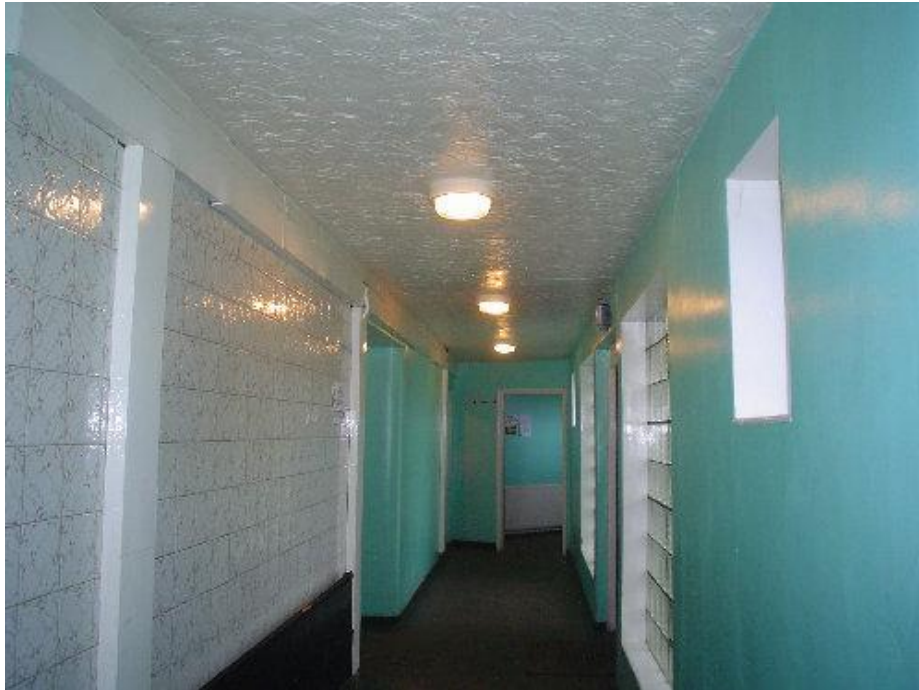
Location ID:	1826	Survey Type:	T 2
Location Ref:	009	Product Type:	NADIS
Product:	Textured coating	Damage:	NADIS
Area:	Main Building	Treatment:	NADIS
Floor:	Ground floor	Asbestos Type:	NADIS
Room:	Corridor 1	Identification:	Identified
Surveyor Name:	Gavin Curley	Quantity:	
Drawing Ref:	D01	Accessibility:	
Asbestos ?	No	Material Risk Score:	0
Date:	07 January 2005	Material Risk Band:	NADIS
Next Inspection:	Not Applicable	Priority Risk Score:	N/A
Analysis:			
Action:	No Action Required

Non asbestos textured coating to ceiling. Parquet floor, concrete step, plaster walls with ceramic tiles, timber boxing to sign in hatch.

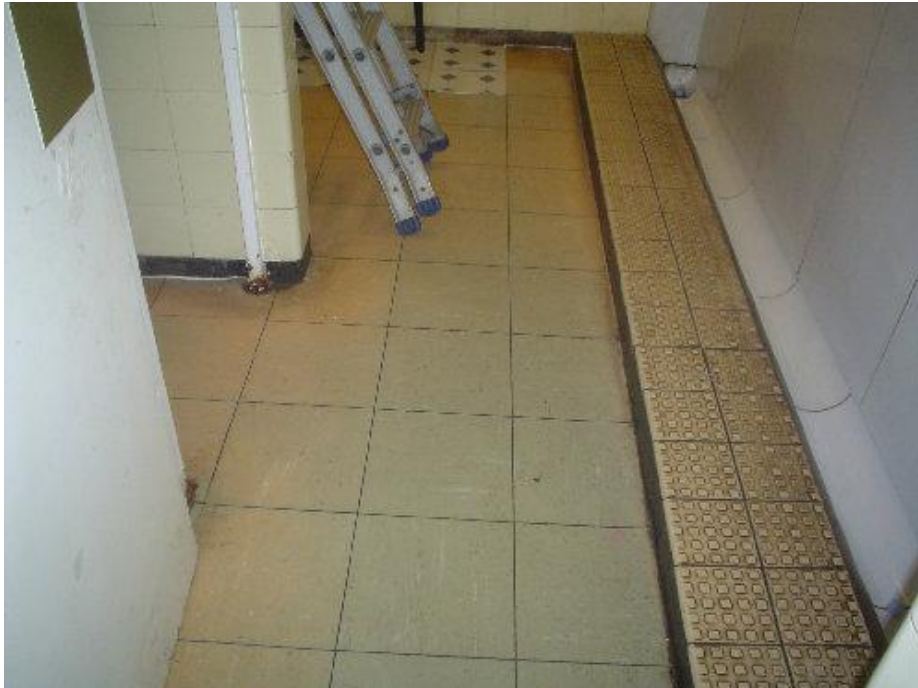
Location ID:	1827	Survey Type:	T 2
Location Ref:	010	Product Type:	NADIS
Product:	Floor tile	Damage:	NADIS
Area:	Main Building	Treatment:	NADIS
Floor:	Ground floor	Asbestos Type:	NADIS
Room:	Gents toilets	Identification:	Identified
Surveyor Name:	Gavin Curley	Quantity:	
Drawing Ref:	D01	Accessibility:	
Asbestos ?	No	Material Risk Score:	0
Date:	07 January 2005	Material Risk Band:	NADIS
Next Inspection:	Not Applicable	Priority Risk Score:	N/A
Analysis:			
Action:	No Action Required

Non asbestos thermoplastic floor tile (TPFT). Plaster walls with ceramic tiles, ceramic cisterns to cubicles with metal partitions and doors. TPFT also extend into small shower room which is of similar construction.

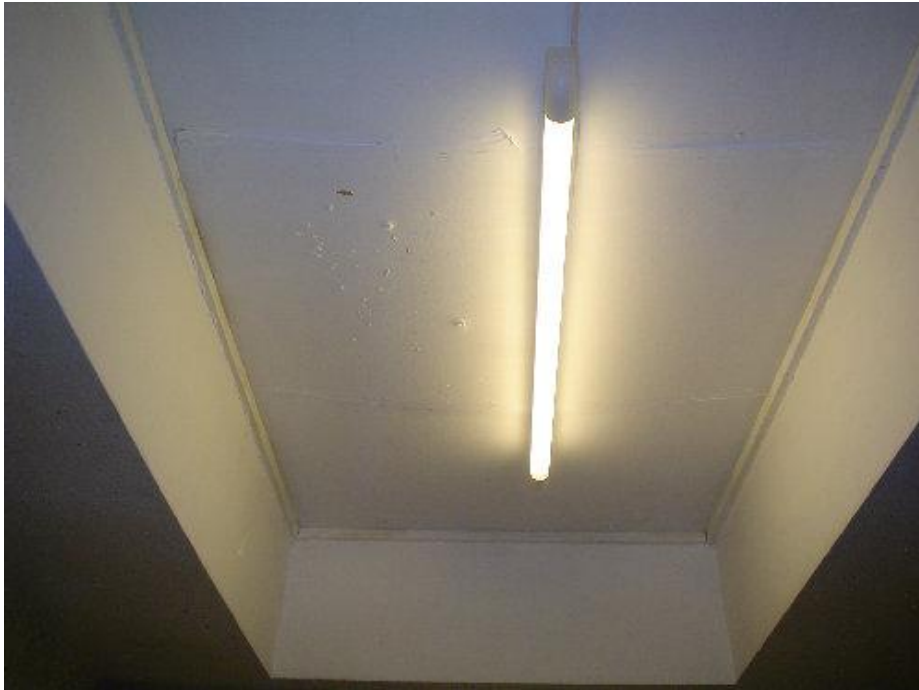
Location ID:	1828	Survey Type:	T 2
Location Ref:	011	Product Type:	NADIS
Product:	Insulating board	Damage:	NADIS
Area:	Main Building	Treatment:	NADIS
Floor:	Ground floor	Asbestos Type:	NADIS
Room:	Gents toilets	Identification:	Identified
Surveyor Name:	Gavin Curley	Quantity:	
Drawing Ref:	D01	Accessibility:	
Asbestos ?	No	Material Risk Score	0
Date:	07 January 2005	Material Risk Band:	NADIS
Next Inspection:	Not Applicable	Priority Risk Score:	N/A
Analysis:			
Action:	No Action Required

Non asbestos insulating board to raised section of ceiling, covering skylight. Plaster and plasterboard ceiling.

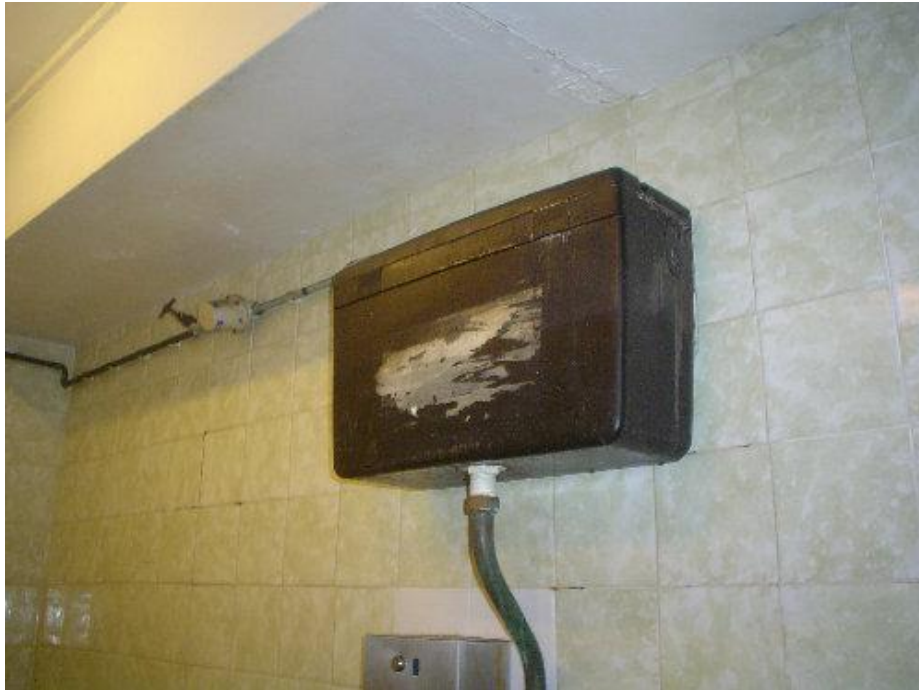
Location ID:	1829	Survey Type:	T 2
Location Ref:	012	Product Type:	NADIS
Product:	Reinforced plastic	Damage:	NADIS
Area:	Main Building	Treatment:	NADIS
Floor:	Ground floor	Asbestos Type:	NADIS
Room:	Gents toilets	Identification:	Identified
Surveyor Name:	Gavin Curley	Quantity:	
Drawing Ref:	D01	Accessibility:	
Asbestos ?	No	Material Risk Score:	0
Date:	07 January 2005	Material Risk Band:	NADIS
Next Inspection:	Not Applicable	Priority Risk Score:	N/A
Analysis:			
Action:	No Action Required

Non asbestos toilet cistern to urinals.

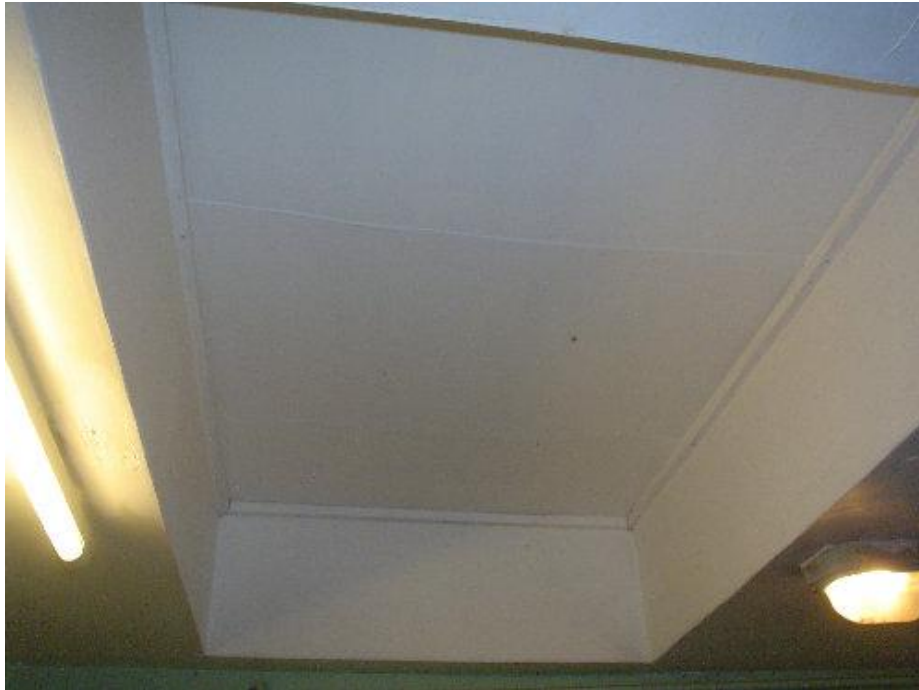
Location ID:	1830	Survey Type:	T 2
Location Ref:	013	Product Type:	NADIS
Product:	Insulating board	Damage:	NADIS
Area:	Main Building	Treatment:	NADIS
Floor:	Ground floor	Asbestos Type:	NADIS
Room:	Gents toilets	Identification:	Identified
Surveyor Name:	Gavin Curley	Quantity:	
Drawing Ref:	D01	Accessibility:	
Asbestos ?	No	Material Risk Score:	0
Date:	07 January 2005	Material Risk Band:	NADIS
Next Inspection:	Not Applicable	Priority Risk Score:	N/A
Analysis:			
Action:	No Action Required

Non asbestos insulating board, as Location Ref: 011, to raised ceiling. Non asbestos lino to floor, plaster and plasterboard walls with ceramic tiles. Timber panel to wall in 1st cubicle, plaster and plasterboard ceiling.

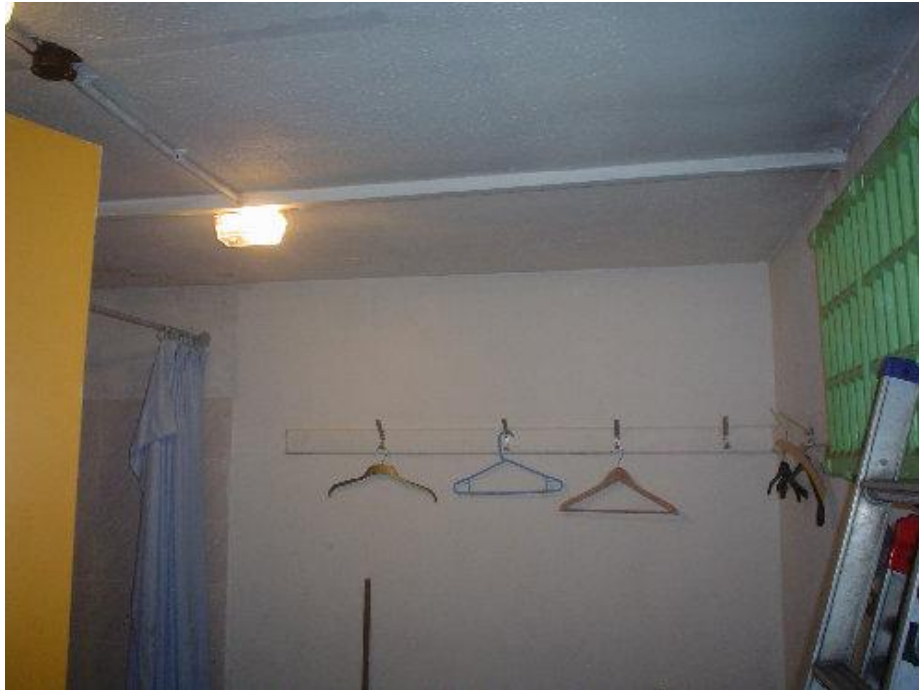
Location ID:	1831	Survey Type:	T 2
Location Ref:	014	Product Type:	NADIS
Product:	Textured coating	Damage:	NADIS
Area:	Main Building	Treatment:	NADIS
Floor:	Ground floor	Asbestos Type:	NADIS
Room:	Shower	Identification:	Identified
Surveyor Name:	Gavin Curley	Quantity:	
Drawing Ref:	D01	Accessibility:	
Asbestos ?	No	Material Risk Score	0
Date:	07 January 2005	Material Risk Band:	NADIS
Next Inspection:	Not Applicable	Priority Risk Score:	N/A
Analysis:			
Action:	No Action Required

Non asbestos textured coating to walls and part of ceiling. Carpet tiles to floor, plaster and plasterboard walls, ceramic tiles to shower area.

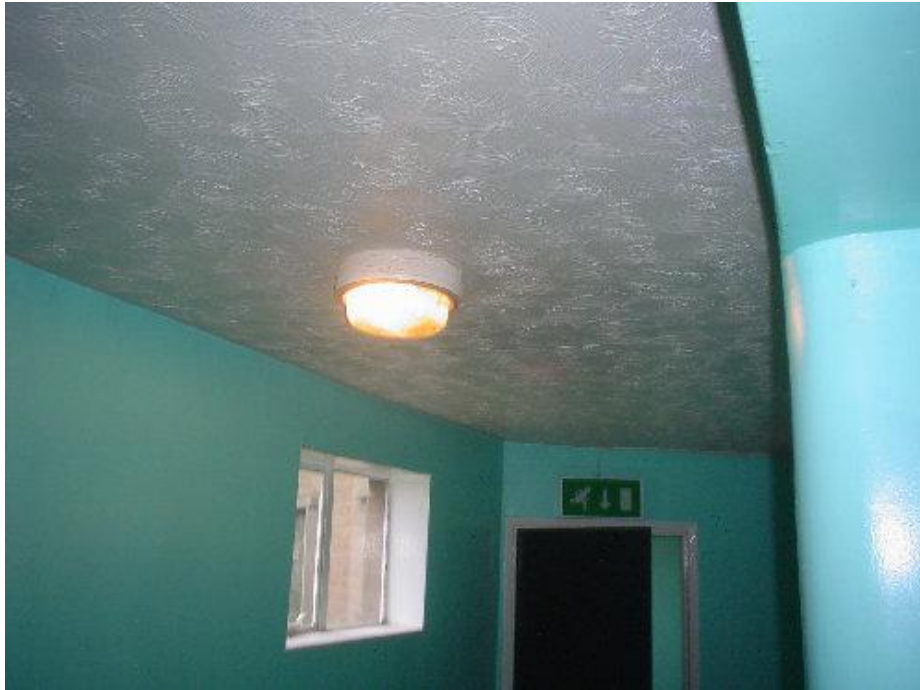
Location ID:	1832	Survey Type:	T 2
Location Ref:	015	Product Type:	NADIS
Product:	Textured coating	Damage:	NADIS
Area:	Main Building	Treatment:	NADIS
Floor:	Ground floor	Asbestos Type:	NADIS
Room:	Corridor 2	Identification:	Identified
Surveyor Name:	Gavin Curley	Quantity:	
Drawing Ref:	D01	Accessibility:	
Asbestos ?	No	Material Risk Score:	0
Date:	07 January 2005	Material Risk Band:	NADIS
Next Inspection:	Not Applicable	Priority Risk Score:	N/A
Analysis:			
Action:	No Action Required

Non asbestos textured coating to ceiling. Parquet floor, plaster walls, timber boxing to metal radiator pipes, this boxing is also present in Corridor 1.

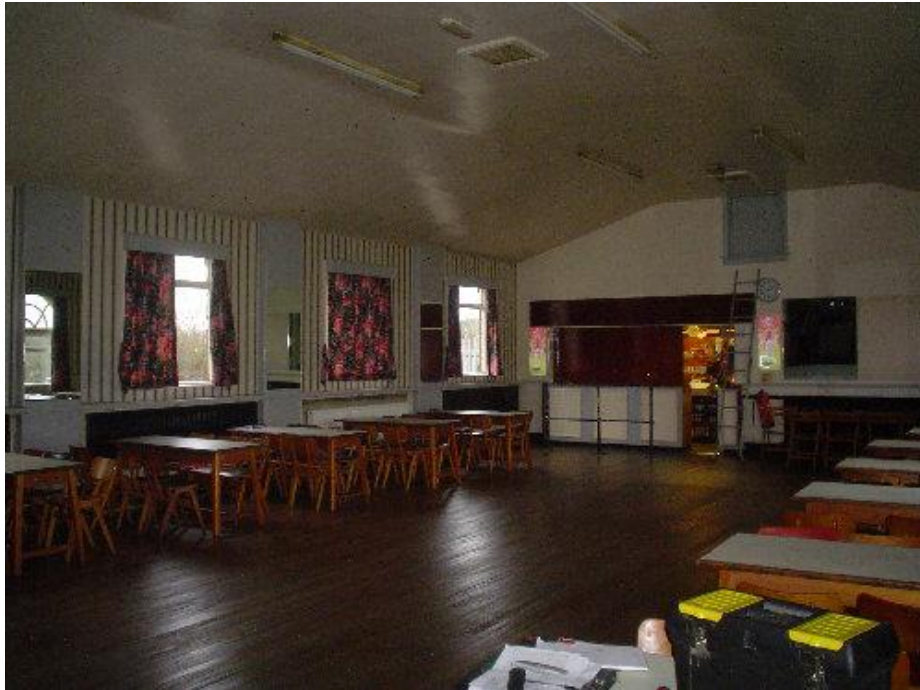
Location ID:	1833	Survey Type:	T 2
Location Ref:	016	Product Type:	Not Applicable
Product:	General view	Damage:	Not Applicable
Area:	Main Building	Treatment:	Not Applicable
Floor:	Ground floor	Asbestos Type:	Not Applicable
Room:	Function room	Identification:	
Surveyor Name:	Gavin Curley	Quantity:	
Drawing Ref:	D01	Accessibility:	
Asbestos ?	No	Material Risk Score	0
Date:	07 January 2005	Material Risk Band:	Not Applicable
Next Inspection:	Not Applicable	Priority Risk Score:	N/A
Analysis:			
Action:	No Action Required

Timber floor, plaster walls and ceiling, unlagged metal pipework, timber shelves to radiators, timber frontage to stage.

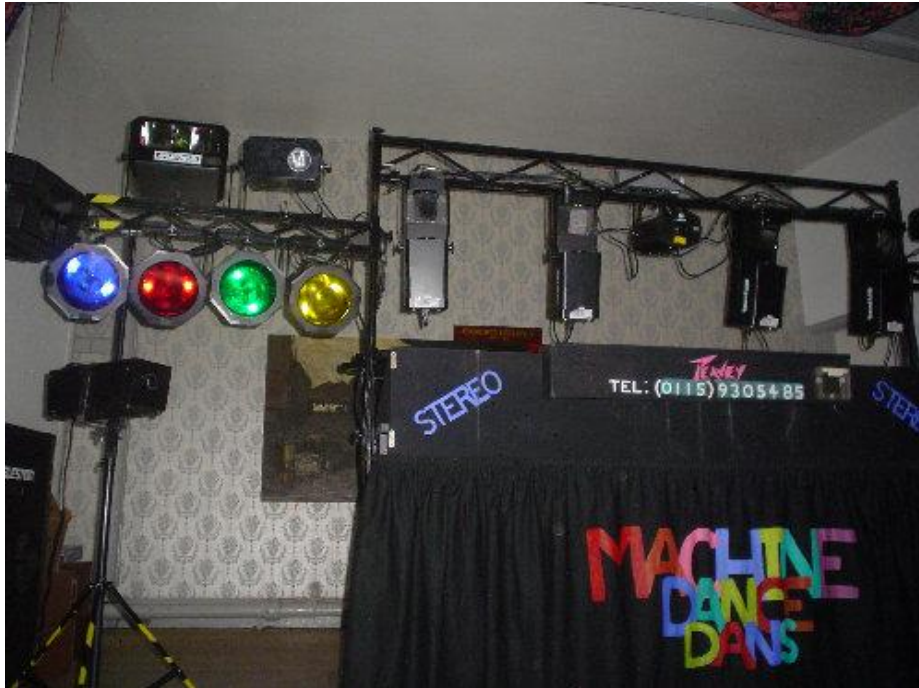
Location ID:	1834	Survey Type:	T 2
Location Ref:	017	Product Type:	Not Applicable
Product:	General view	Damage:	Not Applicable
Area:	Main Building	Treatment:	Not Applicable
Floor:	Ground floor	Asbestos Type:	Not Applicable
Room:	Function room stage	Identification:	
Surveyor Name:	Gavin Curley	Quantity:	
Drawing Ref:	D01	Accessibility:	
Asbestos ?	No	Material Risk Score	0
Date:	07 January 2005	Material Risk Band:	Not Applicable
Next Inspection:	Not Applicable	Priority Risk Score:	N/A
Analysis:			
Action:	No Action Required

Timber floor, plaster and plasterboard ceiling, timber boxing to arch, plaster walls with timber cladding. No access into fuse boxes.

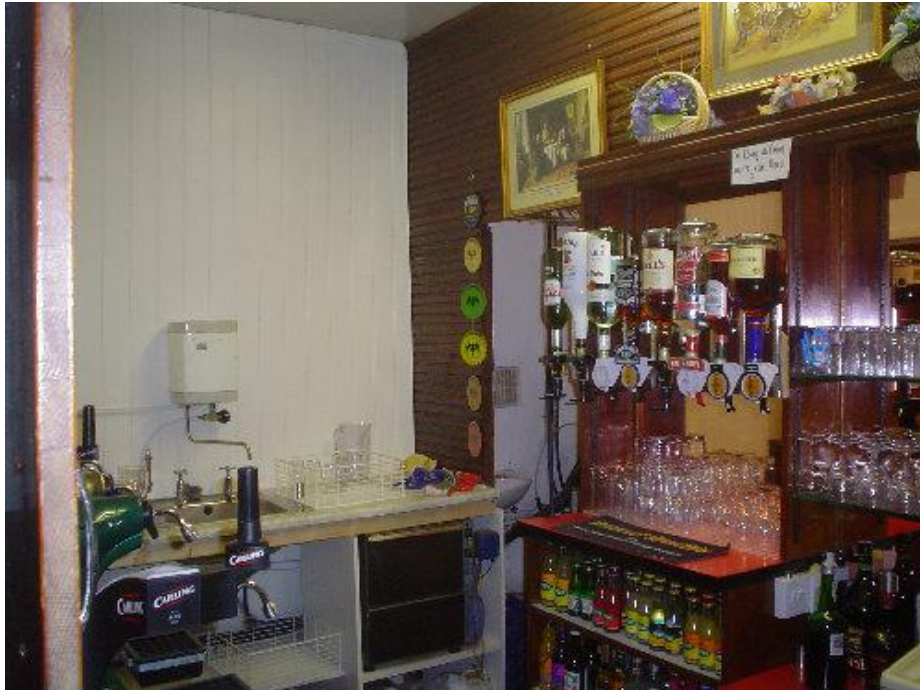
Location ID:	1835	Survey Type:	T 2
Location Ref:	018	Product Type:	Not Applicable
Product:	General view	Damage:	Not Applicable
Area:	Main Building	Treatment:	Not Applicable
Floor:	Ground floor	Asbestos Type:	Not Applicable
Room:	Bar 2	Identification:	
Surveyor Name:	Gavin Curley	Quantity:	
Drawing Ref:	D01	Accessibility:	
Asbestos ?	No	Material Risk Score	0
Date:	07 January 2005	Material Risk Band:	Not Applicable
Next Inspection:	Not Applicable	Priority Risk Score:	N/A
Analysis:			
Action:	No Action Required

Non asbestos lino to floor, plaster and plasterboard walls and ceiling, timber partition wall to barrel store at rear.

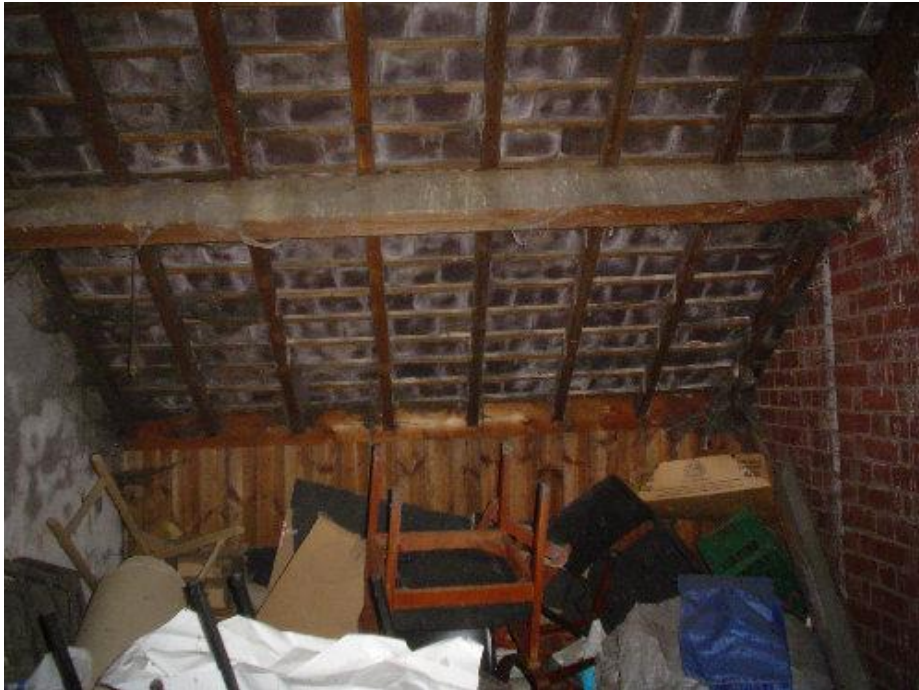
Location ID:	1836	Survey Type:	T 2
Location Ref:	019	Product Type:	Not Applicable
Product:	General view	Damage:	Not Applicable
Area:	Main Building	Treatment:	Not Applicable
Floor:	Ground floor	Asbestos Type:	Not Applicable
Room:	Roof space over Bar 2	Identification:	
Surveyor Name:	Gavin Curley	Quantity:	
Drawing Ref:	D01	Accessibility:	
Asbestos ?	No	Material Risk Score	0
Date:	07 January 2005	Material Risk Band:	Not Applicable
Next Inspection:	Not Applicable	Priority Risk Score:	N/A
Analysis:			
Action:	No Action Required

Timber floor, brick, plaster and timber walls, timber joists to roof tiles. No suspect materials observed to stored items.

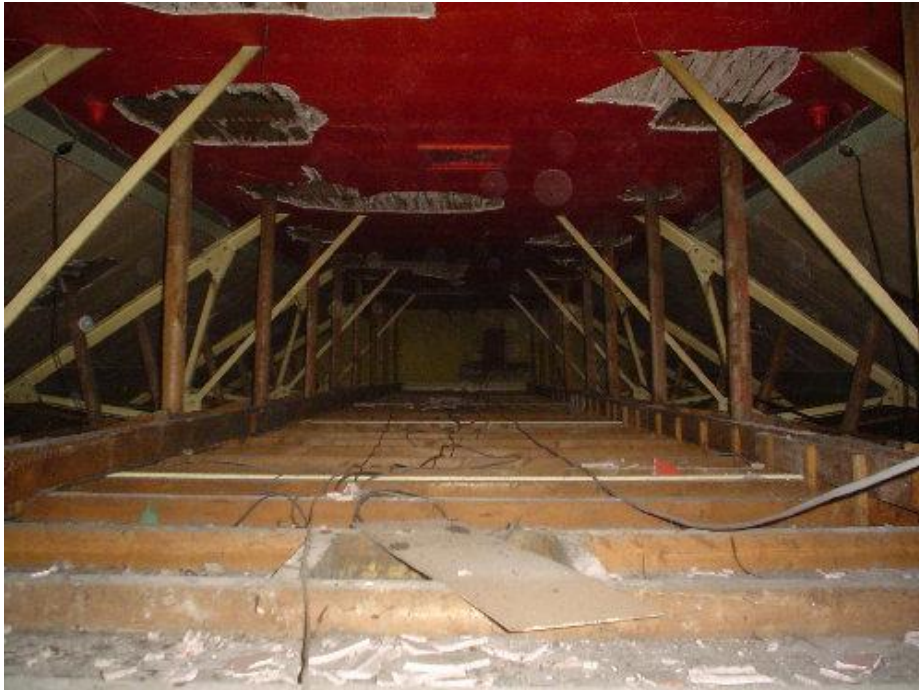
Location ID:	1837	Survey Type:	T 2
Location Ref:	020	Product Type:	Not Applicable
Product:	General view	Damage:	Not Applicable
Area:	Main Building	Treatment:	Not Applicable
Floor:	Ground floor	Asbestos Type:	Not Applicable
Room:	Roof space over Function room	Identification:	
Surveyor Name:	Gavin Curley	Quantity:	
Drawing Ref:	D01	Accessibility:	
Asbestos ?	No	Material Risk Score	0
Date:	07 January 2005	Material Risk Band:	Not Applicable
Next Inspection:	Not Applicable	Priority Risk Score:	N/A
Analysis:			
Action:	No Action Required

Timber and metal joists to plaster and timber ceiling. No suspect materials observed from within Roof space over Bar 2.

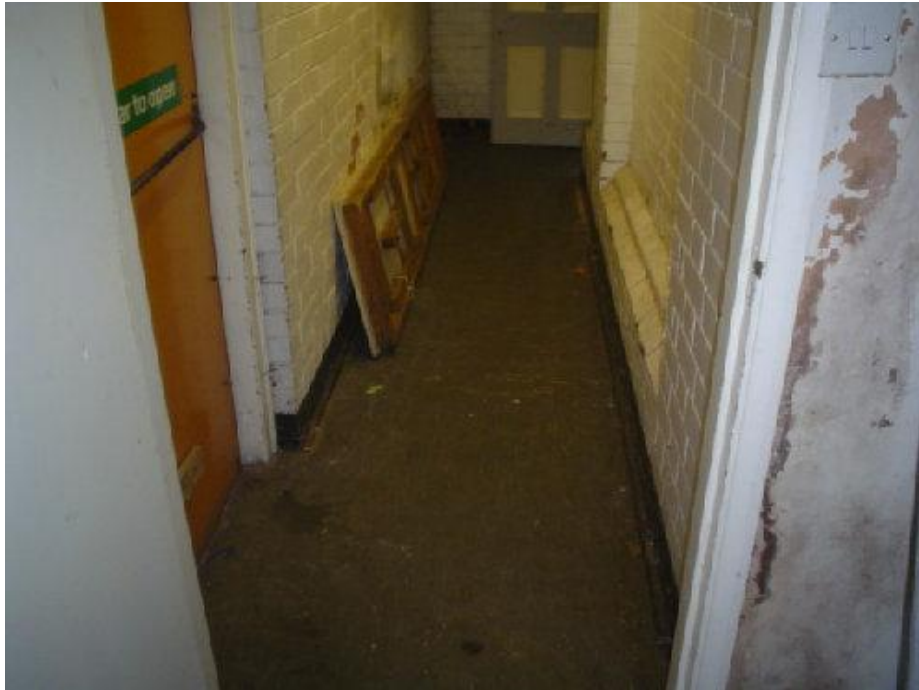
Location ID:	1838	Survey Type:	T 2
Location Ref:	021	Product Type:	NADIS
Product:	Floor covering	Damage:	NADIS
Area:	Main Building	Treatment:	NADIS
Floor:	Ground floor	Asbestos Type:	NADIS
Room:	Kitchen corridor	Identification:	Identified
Surveyor Name:	Gavin Curley	Quantity:	
Drawing Ref:	D01	Accessibility:	
Asbestos ?	No	Material Risk Score:	0
Date:	07 January 2005	Material Risk Band:	NADIS
Next Inspection:	Not Applicable	Priority Risk Score:	N/A
Analysis:			
Action:	No Action Required

Non asbestos lino to floor, brick walls, timber to ceiling.

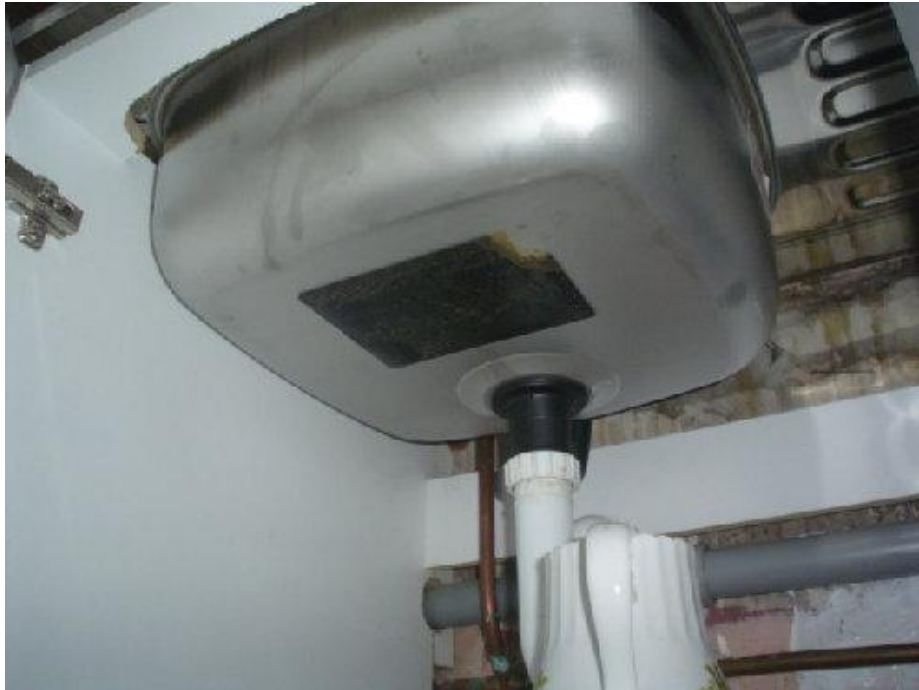
Location ID:	1839	Survey Type:	T 2
Location Ref:	022	Product Type:	NADIS
Product:	Bitumen pad	Damage:	NADIS
Area:	Main Building	Treatment:	NADIS
Floor:	Ground floor	Asbestos Type:	NADIS
Room:	Kitchen	Identification:	Identified
Surveyor Name:	Gavin Curley	Quantity:	
Drawing Ref:	D01	Accessibility:	
Asbestos ?	No	Material Risk Score:	0
Date:	07 January 2005	Material Risk Band:	NADIS
Next Inspection:	Not Applicable	Priority Risk Score:	N/A
Analysis:			
Action:	No Action Required

Non asbestos bitumen pads to sink units. Non asbestos lino to floor, brick and plaster walls with ceramic tiles, plaster ceiling.

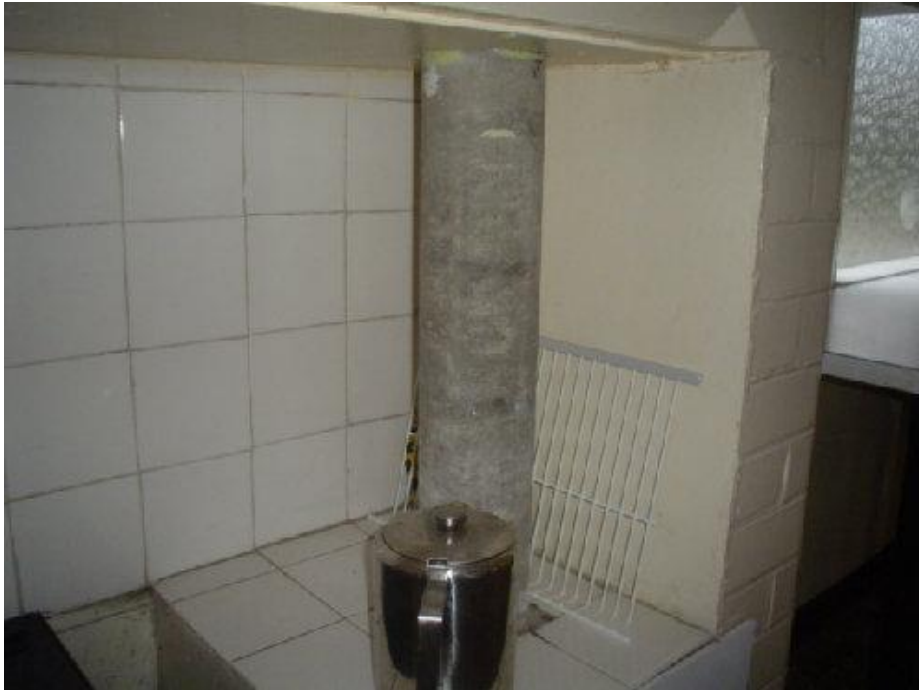
Location ID:	1840	Survey Type:	T 2
Location Ref:	023	Product Type:	Asbestos cement
Product:	Cement	Damage:	Low damage: Scratches or marks
Area:	Main Building	Treatment:	Asbestos cement sheets etc
Floor:	Ground floor	Asbestos Type:	Chrysotile
Room:	Kitchen	Identification:	Identified
Surveyor Name:	Gavin Curley	Quantity:	6 linear metres approx.
Drawing Ref:	D01	Accessibility:	Easy Accessibility
Asbestos ?	Yes		
Date:	07 January 2005		
Next Inspection:	07 January 2006		
Analysis:	Significant		
Action:	Inspect periodically and manage as required

Asbestos cement flue pipe within fireplace. It is strongly suspected that this flue continues up to the roof. No access gained into redundant metal cased fire.

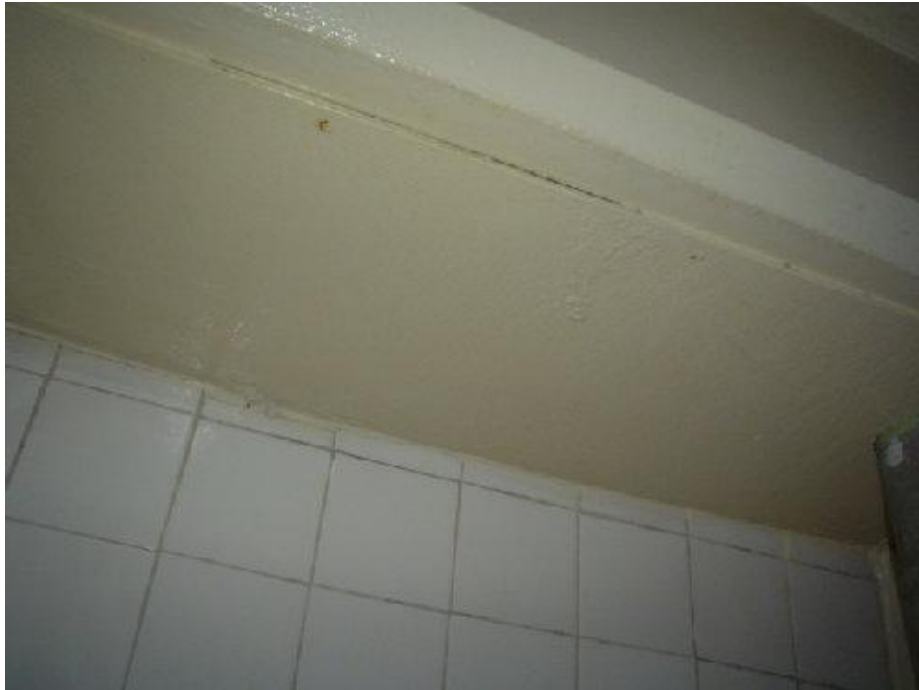
Location ID:	1841	Survey Type:	T 2
Location Ref:	024	Product Type:	Asbestos cement
Product:	Cement	Damage:	Good condition
Area:	Main Building	Treatment:	Asbestos cement sheets etc
Floor:	Ground floor	Asbestos Type:	Chrysotile
Room:	Kitchen	Identification:	Identified
Surveyor Name:	Gavin Curley	Quantity:	2 sqm approx.
Drawing Ref:	D01	Accessibility:	Easy Accessibility
Asbestos ?	Yes		
Date:	07 January 2005		
Next Inspection:	07 January 2006		
Analysis:	Significant		
Action:	Inspect periodically and manage as required

Asbestos cement board within fireplace. No access possible above.

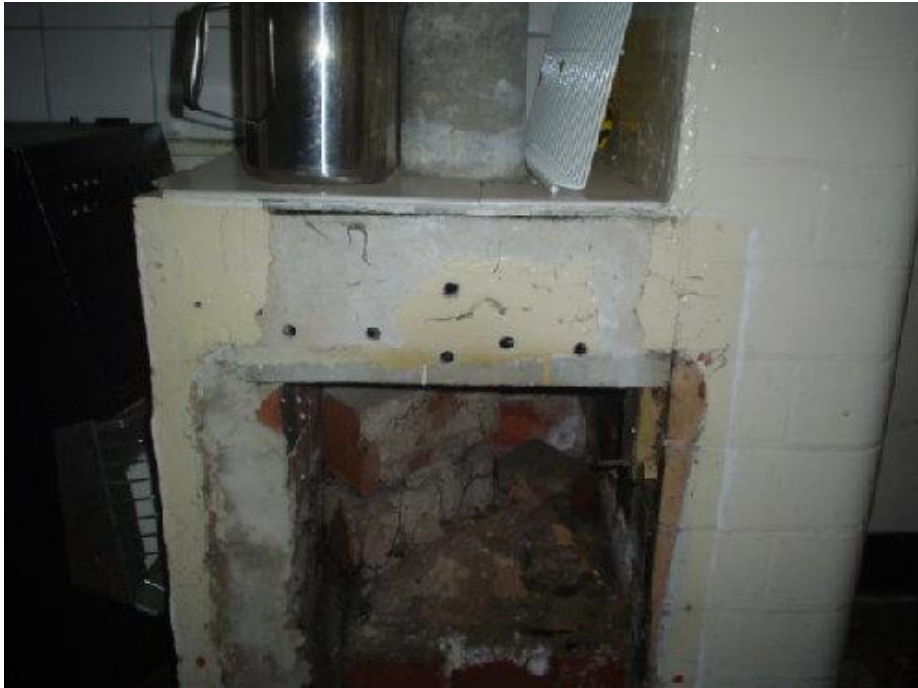
Sample Date	Location Ref	Location ID	Drawing Reference	Area	Floor	Room	Asbestos Type	Product Name	Material Risk Score	Priority Risk Score	Comments	Action	Survey Type
07/01/05	027	1844	D01	Main Building	Basement	Cellar	Amosite & Chrysotile	Pipe insulation	7	N/A	Asbestos containing pipe insulation to pipework in far corner from steps. Concrete floor, brick walls, plaster and timber ceiling, chipboard to walls with pump motors. Remainder of pipework to basement is foam and MMMF, no suspect residues observed below.	Label, inspect periodically and manage as required	T 2
07/01/05	025	1842	D01	Main Building	Ground floor	Kitchen	Chrysotile/Amosite	Insulating board	7	N/A	Asbestos insulating board to rear of drilled timber panel covering fireplace beneath asbestos cement flue pipe.	Apply warning labels, remove at refurbishment	T 2

Location ID:	1842	Survey Type:	T 2
Location Ref:	025	Product Type:	Asbestos Insulating Board
Product:	Insulating board	Damage:	Medium damage: Loose fibres
Area:	Main Building	Treatment:	AIB painted or encapsulated
Floor:	Ground floor	Asbestos Type:	Chrysotile/Amosite
Room:	Kitchen	Identification:	Identified
Surveyor Name:	Gavin Curley	Quantity:	<1 sqm.
Drawing Ref:	D01	Accessibility:	Medium Accessibility
Asbestos ?	Yes		
Date:	07 January 2005		
Next Inspection:	07 April 2005		
Analysis:	Significant		
Action:	Apply warning labels, remove at refurbishment

Asbestos insulating board to rear of drilled timber panel covering fireplace beneath asbestos cement flue pipe.

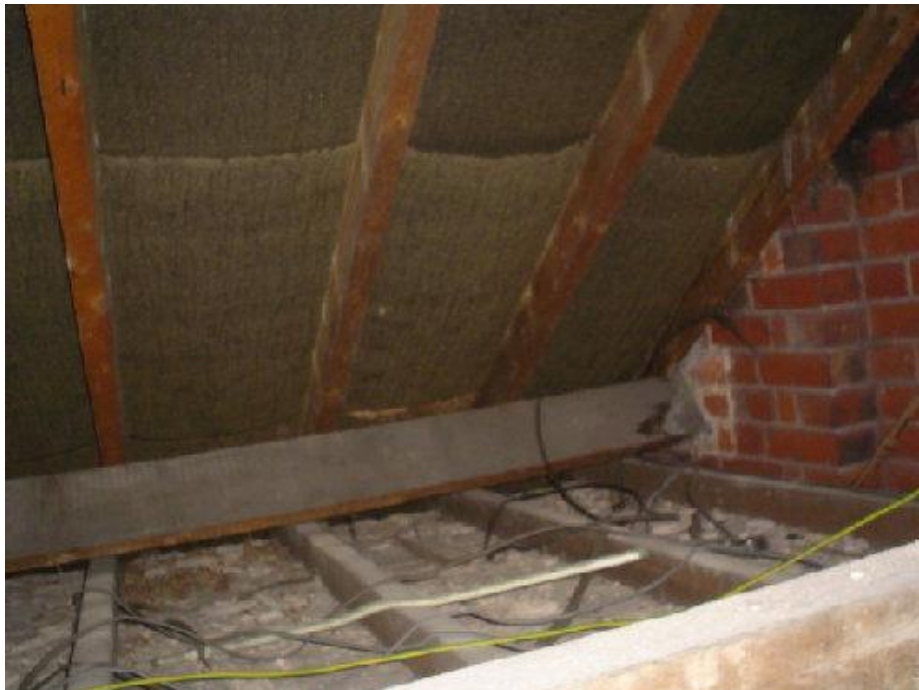
Location ID:	1843	Survey Type:	T 2
Location Ref:	026	Product Type:	NADIS
Product:	Felt	Damage:	NADIS
Area:	Main Building	Treatment:	NADIS
Floor:	Ground floor	Asbestos Type:	NADIS
Room:	Roof space over Kitchen	Identification:	Identified
Surveyor Name:	Gavin Curley	Quantity:	
Drawing Ref:	D01	Accessibility:	
Asbestos ?	No	Material Risk Score:	0
Date:	07 January 2005	Material Risk Band:	NADIS
Next Inspection:	Not Applicable	Priority Risk Score:	N/A
Analysis:			
Action:	No Action Required

Non asbestos felt, as Location Ref: 001, to half of roof. Timber joists to roof tiles, brick walls. Not fully accessed due to lack of crawl boards.

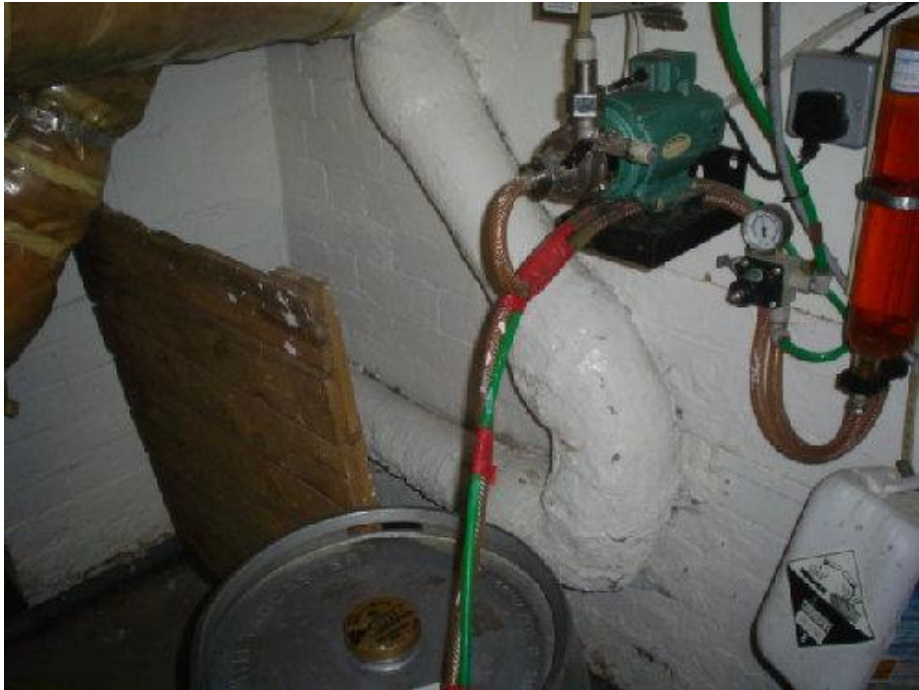
Location ID:	1844	Survey Type:	T 2
Location Ref:	027	Product Type:	Pipe and boiler lagging
Product:	Pipe insulation	Damage:	Low damage: Scratches or marks
Area:	Main Building	Treatment:	Enclosed sprays and lagging
Floor:	Basement	Asbestos Type:	Amosite & Chrysotile
Room:	Cellar	Identification:	Identified
Surveyor Name:	Gavin Curley	Quantity:	3 linear metres approx.
Drawing Ref:	D01	Accessibility:	Easy Accessibility
Asbestos ?	Yes		
Date:	07 January 2005		
Next Inspection:	07 April 2005		
Analysis:	Significant		
Action:	Label, inspect periodically and manage as required

Asbestos containing pipe insulation to pipework in far corner from steps. Concrete floor, brick walls, plaster and timber ceiling, chipboard to walls with pump motors. Remainder of pipework to basement is foam and MMMF, no suspect residues observed below.
