Asbestos Survey for

Codnor Miners Welfare Club

Client Name:	Codnor Miners Welfare Club	Project Number:	S2438
		Survey Date:	07 January 2005
Site Address:	Codnor Miners Welfare Club, Goose Lane, Codnor, Ripley, Derbyshire, DE5 9RG	Printed On:	10 February 2005
		Recommendation:	Page 1 of 3

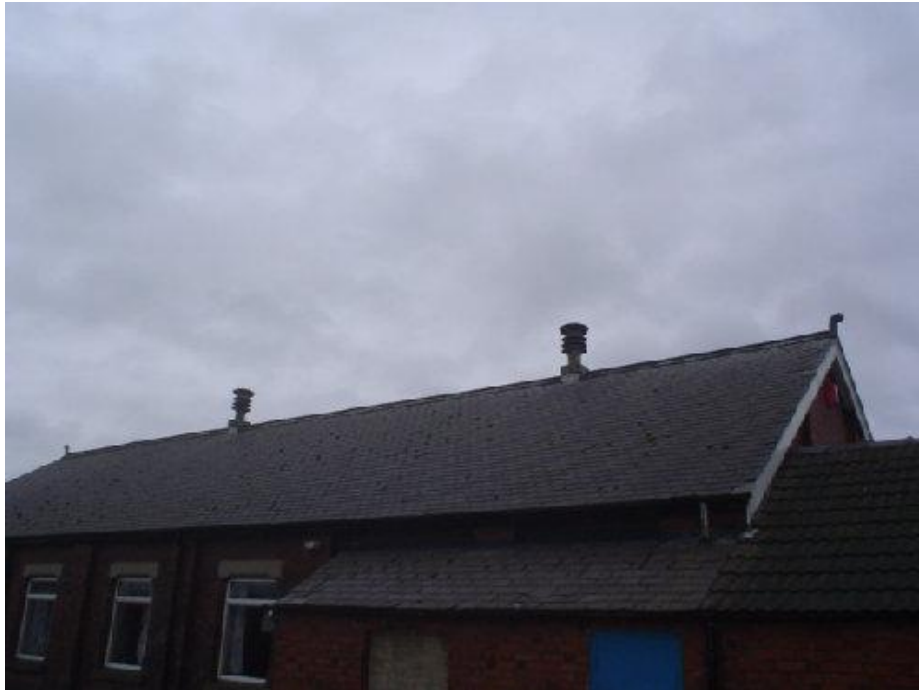
Location ID:	1845	Survey Type:	T 2
Location Ref:	028	Product Type:	Asbestos cement
Product:	Cement	Damage:	No visible damage
Area:	Main Building	Treatment:	Asbestos cement sheets etc
Floor:	Ground floor	Asbestos Type:	Chrysotile
Room:	External	Identification:	Strongly Presumed
Surveyor Name:	Gavin Curley	Quantity:	4 no.
Drawing Ref:	D01	Accessibility:	Difficult Accessibility
Asbestos ?	Yes		
Date:	07 January 2005		
Next Inspection:	07 January 2006		
Analysis:	Significant		
Action:	Inspect periodically and manage as required

No access up to cowls to roof of Function room and Bar lounge, strongly presumed to be asbestos cement.

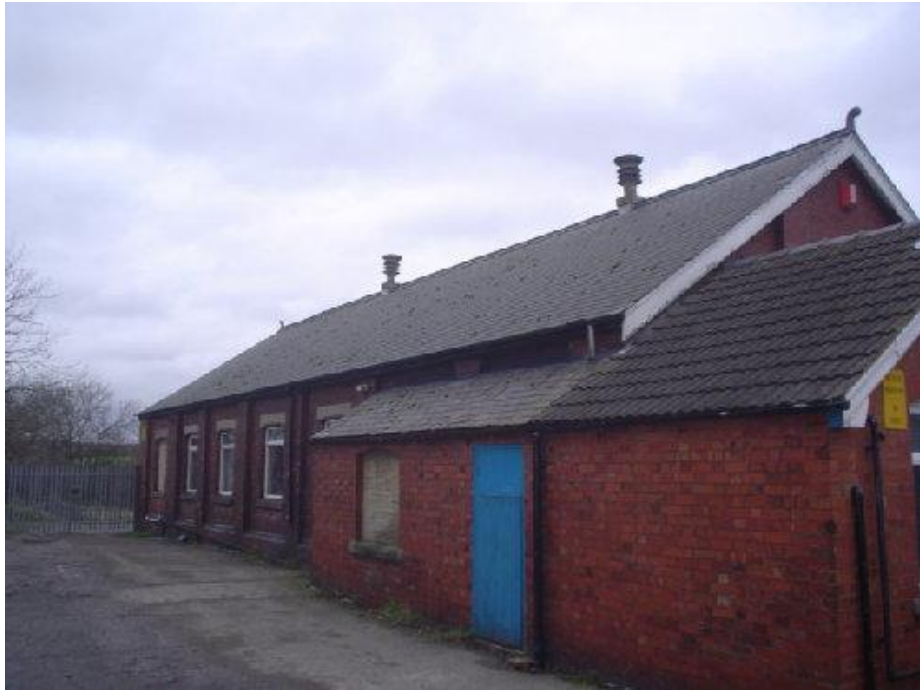
Location ID:	1846	Survey Type:	T 2
Location Ref:	029	Product Type:	Not Applicable
Product:	General view	Damage:	Not Applicable
Area:	Main Building	Treatment:	Not Applicable
Floor:	Ground floor	Asbestos Type:	Not Applicable
Room:	External	Identification:	
Surveyor Name:	Gavin Curley	Quantity:	
Drawing Ref:	D01	Accessibility:	
Asbestos ?	No	Material Risk Score	0
Date:	07 January 2005	Material Risk Band:	Not Applicable
Next Inspection:	Not Applicable	Priority Risk Score:	N/A
Analysis:			
Action:	No Action Required

Slate roof tiles over Kitchen, Function room and Bar lounge. Other pitched roofs have stone tiles, plastic and metal rainwater goods, timber soffits.

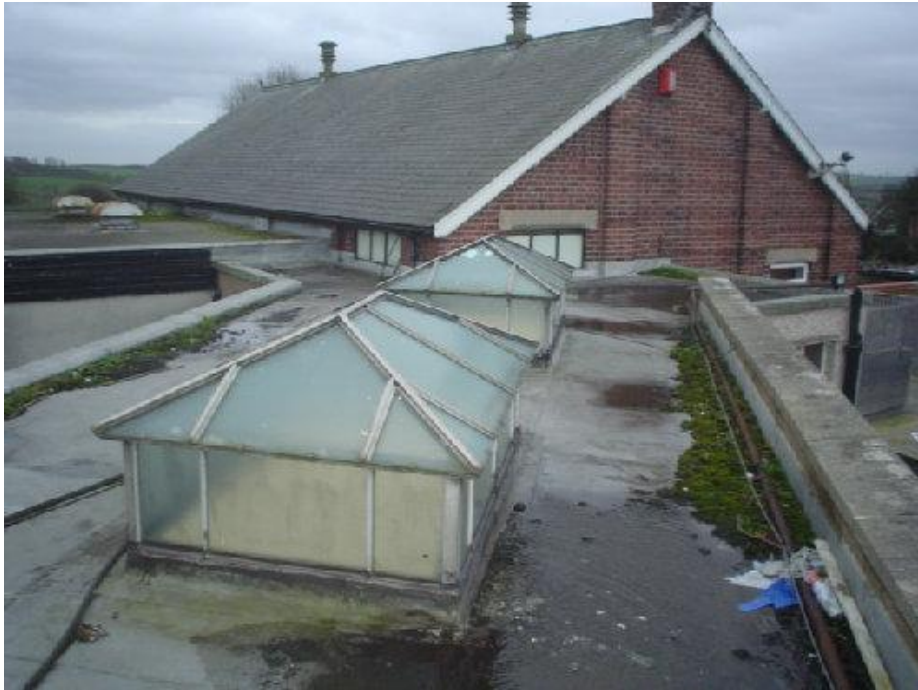
Location ID:	1847	Survey Type:	T 2
Location Ref:	030	Product Type:	Ropes and woven textiles
Product:	Rope	Damage:	No visible damage
Area:	Main Building	Treatment:	Composite asbestos materials
Floor:	Roof	Asbestos Type:	Chrysotile
Room:	External	Identification:	Strongly Presumed
Surveyor Name:	Gavin Curley	Quantity:	6 linear metres approx.
Drawing Ref:	D01	Accessibility:	Difficult Accessibility
Asbestos ?	Yes		
Date:	07 January 2005		
Next Inspection:	07 January 2006		
Analysis:	Dominant		
Action:	Inspect periodically and manage as required

No access to window bars of skylights, it is possible that asbestos rope insulation may be present to the mobile window perimeters.

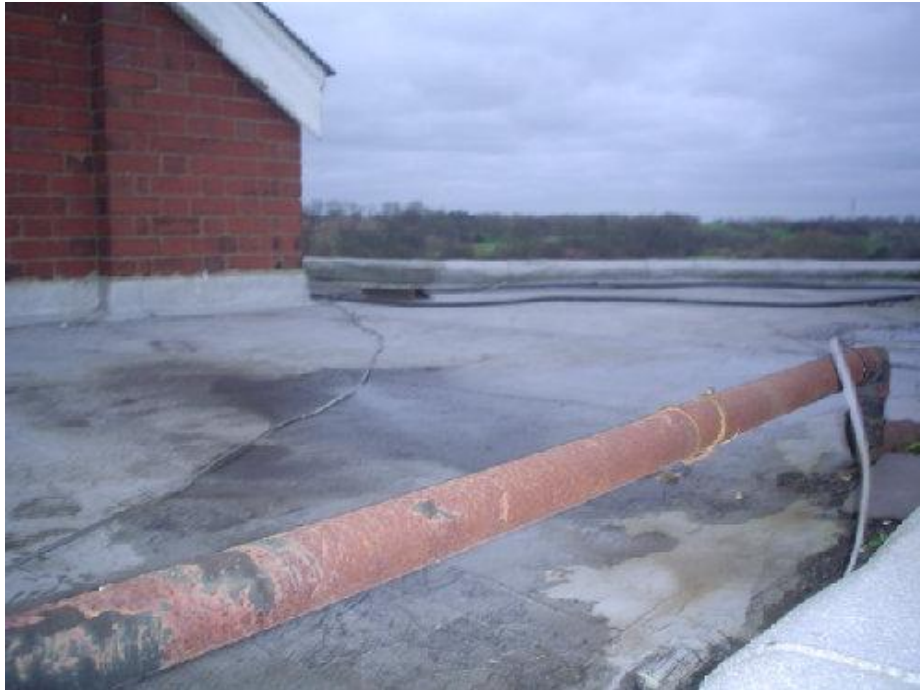
Location ID:	1848	Survey Type:	T 2
Location Ref:	031	Product Type:	NADIS
Product:	Felt	Damage:	NADIS
Area:	Main Building	Treatment:	NADIS
Floor:	Roof	Asbestos Type:	NADIS
Room:	External	Identification:	Identified
Surveyor Name:	Gavin Curley	Quantity:	
Drawing Ref:	D01	Accessibility:	
Asbestos ?	No		
Date:	07 January 2005		
Next Inspection:	Not Applicable		
Analysis:			
Action:	No Action Required

Non asbestos felt covering to flat roof. Timber canopy observed to main entrance doors.

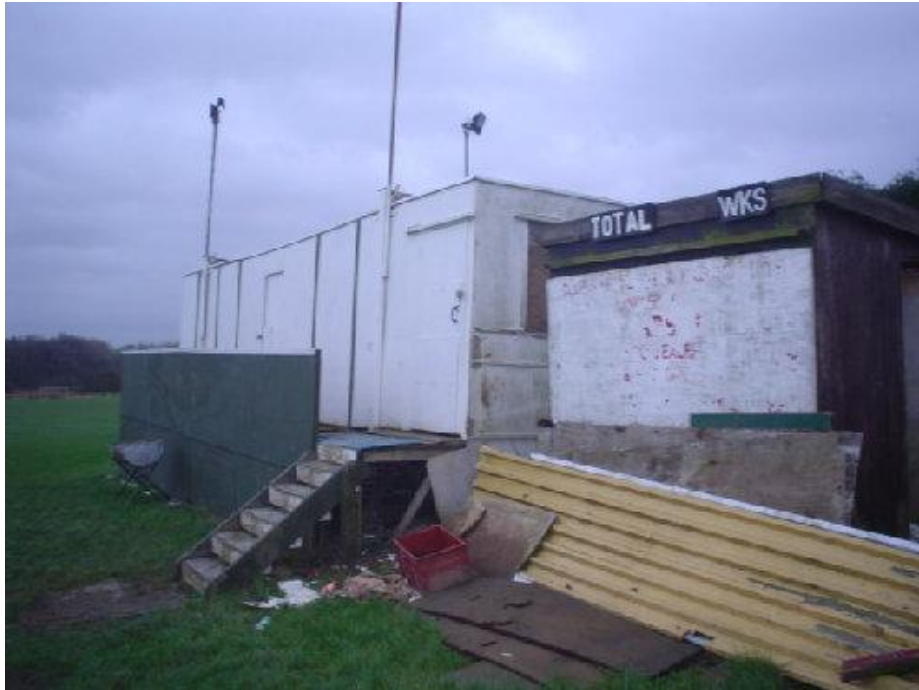
Location ID:	1849	Survey Type:	T 2
Location Ref:	032	Product Type:	Not Applicable
Product:	General view	Damage:	Not Applicable
Area:	Outbuildings	Treatment:	Not Applicable
Floor:	Ground floor	Asbestos Type:	Not Applicable
Room:	Changing rooms & sheds	Identification:	
Surveyor Name:	Gavin Curley	Quantity:	
Drawing Ref:	D01	Accessibility:	
Asbestos ?	No	Material Risk Score	0
Date:	07 January 2005	Material Risk Band:	Not Applicable
Next Inspection:	Not Applicable	Priority Risk Score:	N/A
Analysis:			
Action:	No Action Required

Timber construction to changing rooms and adjacent shed. New green shed is also of simialr external construction.

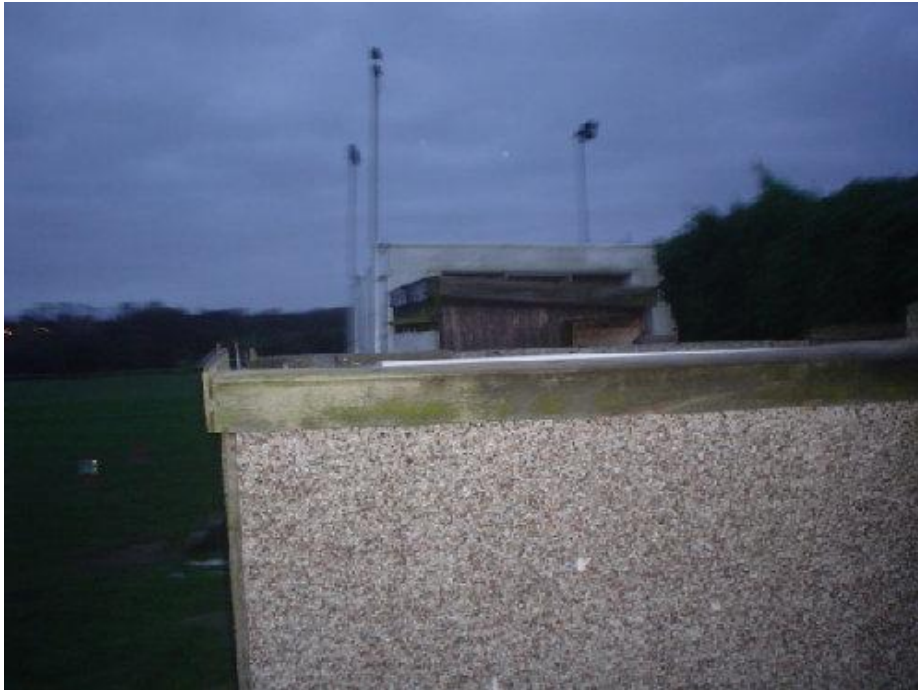
Location ID:	1850	Survey Type:	T 2
Location Ref:	033	Product Type:	Asbestos cement
Product:	Cement	Damage:	Low damage: Scratches or marks
Area:	Outbuildings	Treatment:	Asbestos cement sheets etc
Floor:	Ground floor	Asbestos Type:	Chrysotile
Room:	Garage	Identification:	Identified
Surveyor Name:	Gavin Curley	Quantity:	12 sqm approx.
Drawing Ref:	D01	Accessibility:	Medium Accessibility
Asbestos ?	Yes		
Date:	07 January 2005		
Next Inspection:	07 January 2006		
Analysis:	Significant		
Action:	Inspect periodically and manage as required

Asbestos cement profiled roof to garage. Concrete walls, metal door with timber cladding to front.

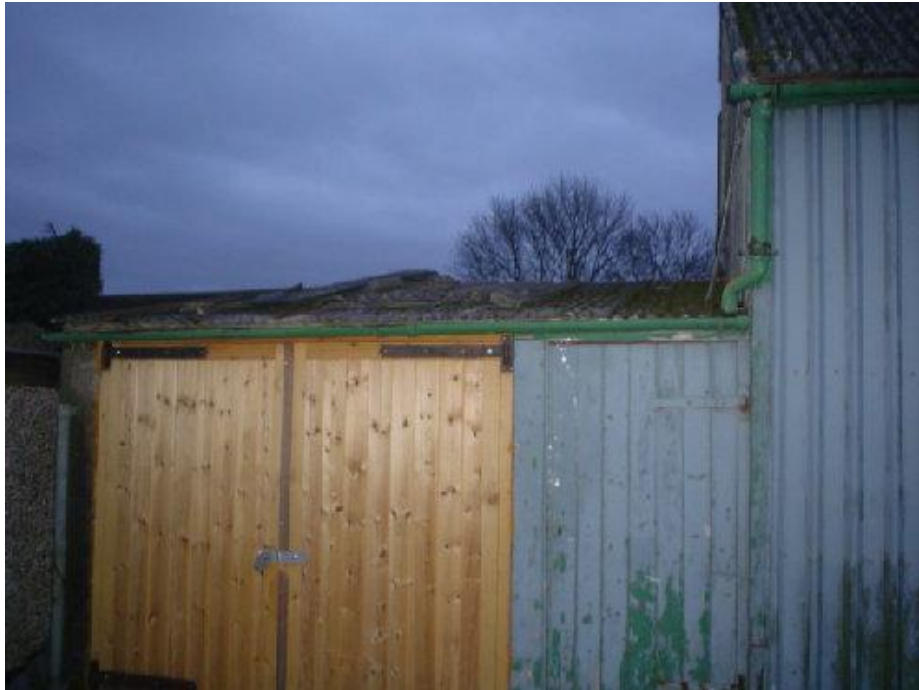
Location ID:	1851	Survey Type:	T 2
Location Ref:	034	Product Type:	Asbestos cement
Product:	Cement	Damage:	Low damage: Broken edge boards
Area:	Outbuildings	Treatment:	Asbestos cement sheets etc
Floor:	Ground floor	Asbestos Type:	Chrysotile
Room:	Store to bowling pavillion	Identification:	Identified
Surveyor Name:	Gavin Curley	Quantity:	20 sqm approx.
Drawing Ref:	D01	Accessibility:	Medium Accessibility
Asbestos ?	Yes		
Date:	07 January 2005		
Next Inspection:	07 January 2006		
Analysis:	Significant		
Action:	Repair damage, inspect periodically and manage

Material Risk Score: 4
Material Risk Band: Very Low Risk
Priority Risk Score: N/A

Asbestos cement profiled roof to store, as Location Ref: 033. Access gained only into small side store. Concrete floor, brick, breeze and fibreboard walls, metal rainwater goods.

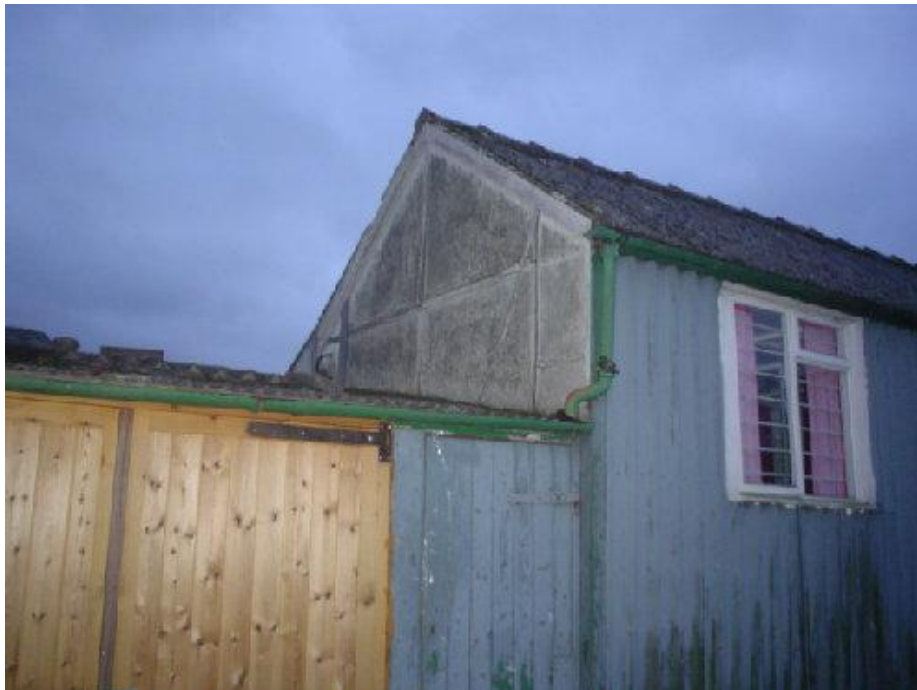
Location ID:	1852	Survey Type:	T 2
Location Ref:	035	Product Type:	Asbestos cement
Product:	Cement	Damage:	Low damage: Scratches or marks
Area:	Outbuildings	Treatment:	Asbestos cement sheets etc
Floor:	Ground floor	Asbestos Type:	Chrysotile
Room:	Bowling pavillion	Identification:	Identified
Surveyor Name:	Gavin Curley	Quantity:	20 sqm approx.
Drawing Ref:	D01	Accessibility:	Medium Accessibility
Asbestos ?	Yes		
Date:	07 January 2005		
Next Inspection:	07 January 2006		
Analysis:	Significant		
Action:	Inspect periodically and manage as required

Material Risk Score: 4
Material Risk Band: Very Low Risk
Priority Risk Score: N/A

Asbestos cement sheets to gable end and to front elevation. It is strongly suspected that asbestos cements sheets are present under the profiled metal cladding around the pavillion. Metal and plastic rainwater goods.

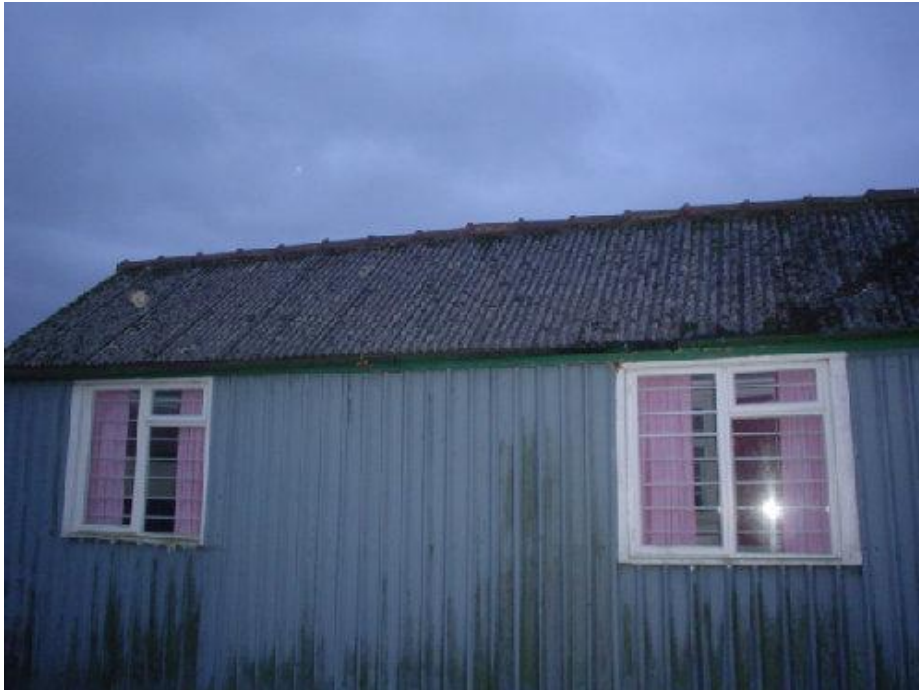
Asbestos cement profiled roof, as Location Ref: 033. Cement roofing also present over seating area to front elevation. Chipboard lining under roof over seats, concrete floor.

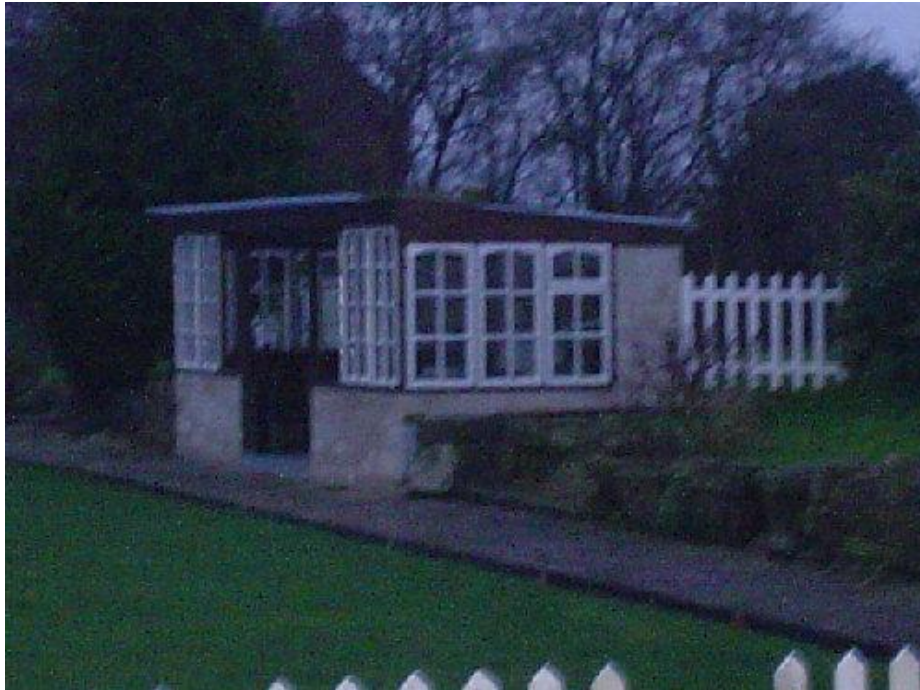
Location ID:	1854	Survey Type:	T 2
Location Ref:	037	Product Type:	Not Applicable
Product:	General view	Damage:	Not Applicable
Area:	Outbuildings	Treatment:	Not Applicable
Floor:	Ground floor	Asbestos Type:	Not Applicable
Room:	Bowling green seating	Identification:	
Surveyor Name:	Gavin Curley	Quantity:	
Drawing Ref:	D01	Accessibility:	
Asbestos ?	No	Material Risk Score	0
Date:	07 January 2005	Material Risk Band:	Not Applicable
Next Inspection:	Not Applicable	Priority Risk Score:	N/A
Analysis:			
Action:	No Action Required

Concrete floor, breeze block walls, timber frame to profiled plastic roof.
