# **DDA Audit for**

Codnor Miners Welfare

<i>ACM Management Solutions Ltd</i>	<b>Project Number:</b>	2438
	<b>Audit Date:</b>	07 January 2005
	<b>Printed On:</b>	11 January 2005
	<b>Page:</b>	Page 1 of 1

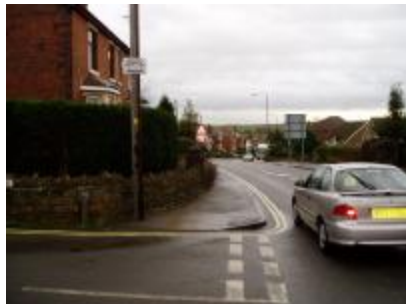
**Location Ref:** 001

**Defect:** Signage relating to Miners welfare club is temporary and relatively small. Goose Lane road signage in poor condition to left hand side of lane only.

**Inspection Notes:**  
Good tactile paving and dropped kerbs to footpath.

**Priority:** B - ASAP

**Work Required:** Install improved and permanent identification sign. Contact Local Authority with regard to upgrading Goose Lane sign.

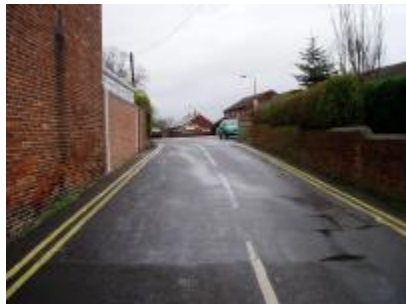
**Location Ref:** 002

**Defect:** Limited road width and no footpath to the first 30 metres.

**Inspection Notes:**  
Restricted width prevents footpath installation. Gradient of 4 degrees to first 30 metres may present difficulty to unaccompanied manual wheelchair user.

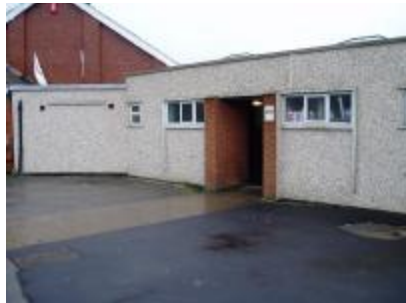
**Location Ref:** 003

**Defect:** No entrance sign.

**Inspection Notes:**  
Good levels, 30 newtons door closer strength, 700mm single door width. Second door locked. No intercom, not required during normal working hours, except for independent wheelchair users. Internal door handle height of 900mm to 1200mm.

**Priority:** B - ASAP

**Work Required:** Install entrance sign and ensure that both doors remain unlocked during opening hours to facilitate wheelchair access.

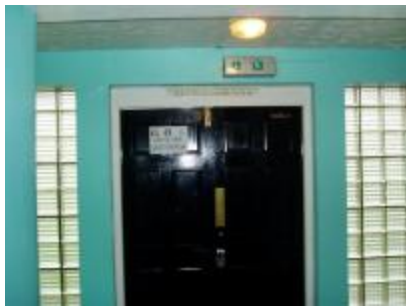
Location Ref: 004

Defect: No signage to bar or function room. Fire exit sign over padlocked door.

**Inspection Notes:**  
Lack of definitive signs may cause confusion to first time visitors. Suggest client undertakes fire risk assessment with regard to routes of egress etc.

Work Required: Install signage. Define fire exit door.

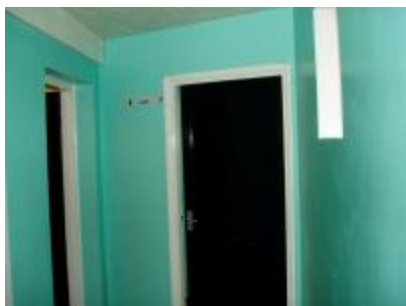
Location Ref: 005

Defect: Position of dividing wall & door inhibits the installation of ramped access to Function Romm (see Inspection No 006).

Work Required: Removal of door and surrounding partition wall will facilitate ramped access.

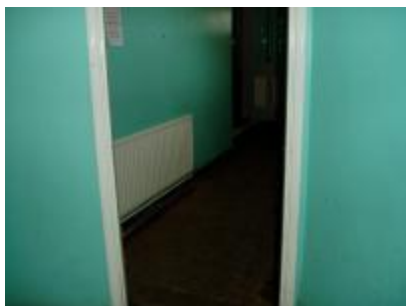
Location Ref: 006

Defect: Stepped access to Function room. Approximately 160mm in height.

**Inspection Notes:**  
Level change presents obstacle to unassisted wheelchair user.

Work Required: Install landing adjacent to function room door with ramp ideally at a gradient of 1 in 20 up to internal door (recommended removal of partition wall - see 005). Install handrails alongside ramp.

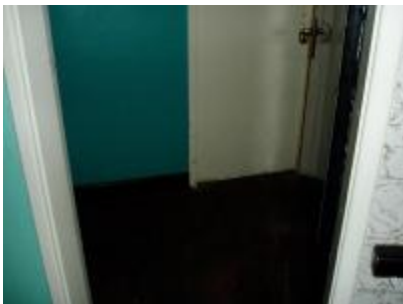
Location Ref: 008

Defect: Raised threshold to lobby of approximately 20mm at entrance to Ladies WC.

Door width of 710mm. Gents WC entrance is of similar construction.

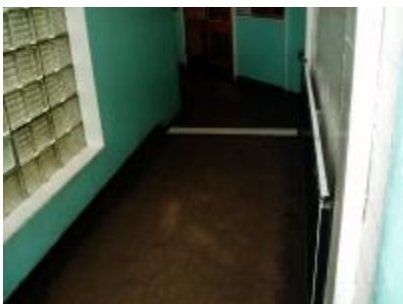
Location Ref: 009

Defect: Step down in corridor leading to bar. Step is 120mm high and has strong contrasting colour to edge, handrail is situated to one side at a height of 770mm.

Level change presents obstacle to unaccompanied wheelchair user.

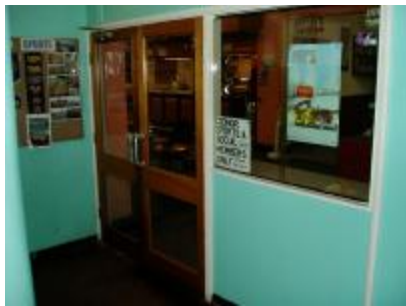
Location Ref: 010

Defect: No contrast to leading edge of door. Door opening strength of 35 newtons. Single door opening width of 715mm.

Inspection Notes:  
Good levels, vision panels present at low and high heights. Door handle height of 910mm to 1150mm.

Work Required: Install contrasting strip to leading edge of door. Install single wider door.

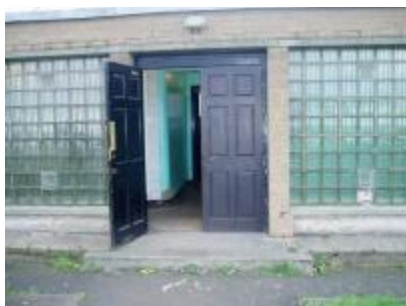
Location Ref: 011

Defect: Timber door water barrier to floor causes trip hazard (25mm high). External step of 140mm & small landing. Single door width of 710mm. No usable door handles or closers present. No clear signage externally.

Inspection Notes:  
Double doors to rear external. Doors used daily as main access from rear car park. Doors padlocked internally, but sign indicates fire exit.

Work Required: Install new wider single door at next refit and remove water barrier. Consider use of door and install appropriate signage.

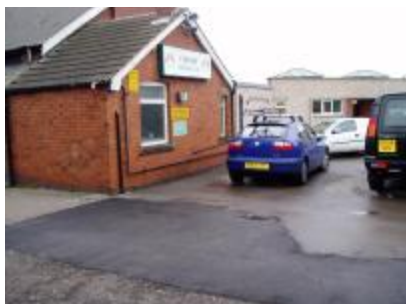
Location Ref: 012

Defect: No marked bays & poor signage to front carpark.

Inspection Notes:  
Condition of surface requires monitoring as further deterioration may lead to trip hazards. Consider upgrading surface longterm. Lighting appears adequate (audit carried out during daylight hours).

Work Required: Mark out designated disabled parking bays. Upgrade signage to provide clear instructions regarding car park usage.

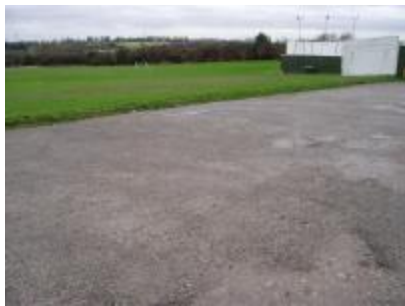
Location Ref: 013

Defect: No marked bays & poor signage to rear carpark. No ramped access from Car park to main building.

**Inspection Notes:**  
Condition of surface requires monitoring as further deterioration may lead to trip hazards. Consider upgrading surface longterm. Lighting appears adequate (audit carried out during daylight hours).

Work Required: Mark out designated disabled parking bays. Upgrade signage to provide clear instructions regarding car park usage and directions to entrance. Install ramped access at gradient of 1 in 20 to allow access to main building.

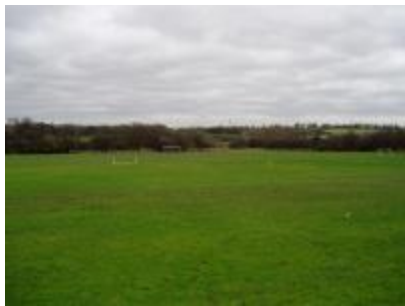
Location Ref: 014

Defect: No useable paths for wheelchair access to sports field (for viewing purposes).

**Inspection Notes:**  
Car park can be used for remote viewing, but this may be considered unreasonable for lower pitches.

Work Required: Incorporate paths into perimeter of sports field, or alternatively re-configure sports fields to enable close up viewing from carpark.

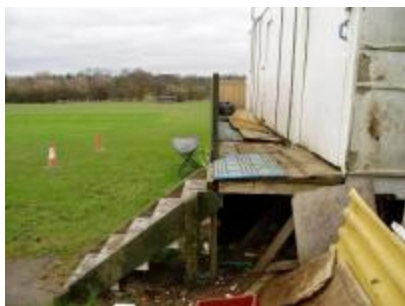
Location Ref: 015

Defect: No handrails to steps. Changing rooms in very poor condition raising general health and safety issues. Uneven surfaces and trip hazards to external parts.

**Inspection Notes:**  
Changing facilities were found to be in very poor condition & may require replacement (not accessed internally).

Work Required: Substantial remedial works required to staircase & surfaces.

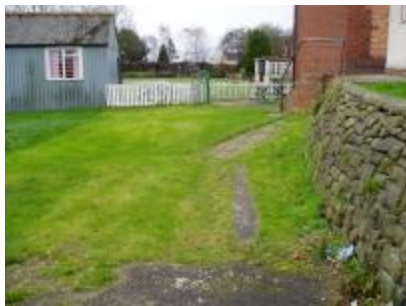
Location Ref: 016

Defect: Footpath from rear carpark to bowling green is inadequate.

**Inspection Notes:**  
Narrow, ill defined concrete path, with overgrown vegetation.

Work Required: Construction of sufficient pathway to allow ambulant disabled and wheelchair access.

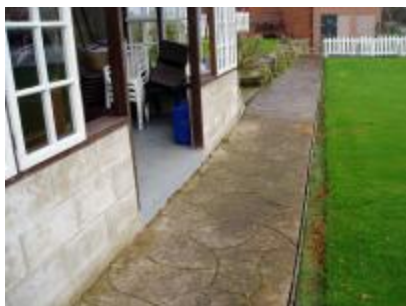
Location Ref: 017

Defect: No viewing area provided for wheelchair users. 130mm high step to seating area.

**Inspection Notes:**  
Sheltered seating area ideally suited to wheelchair users, subject to ramped access. Some benches stored within seating area.

Work Required: Install ramped access and landing to seating area.

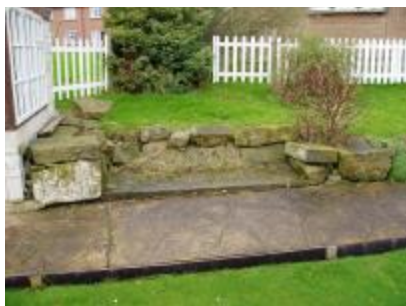
Location Ref: 018

Defect: No recessed seating for wheelchair users.

**Inspection Notes:**  
Recessed seating area adjacent to sheltered viewing area.

Work Required: Reduce level to match footpath, widen seating area to provide space for wheelchairs alongside benches.

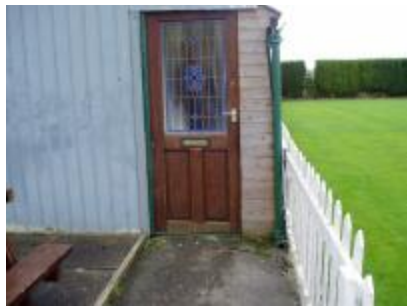
Location Ref: 019

Defect: 710mm width of single door, 20mm threshold to door, 1050mm handle height.

Inspection Notes:  
Entrance to pavillion seating area & refreshments area should be modified to enable whelchair users to gain access.

Work Required: Widen door to facilitate wheelchair access.

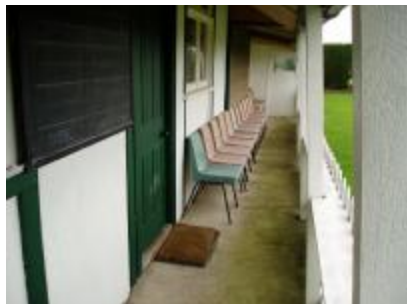
Location Ref: 020

Defect: Narrow thoroughfare of 1040mm width, 65mm threshold at doorway into pavillion.

Inspection Notes:  
Good level surface to viewing area.

Work Required: Remove door threshold to enable wheelchair users to gain access (in conjunction with inspection No. 020).

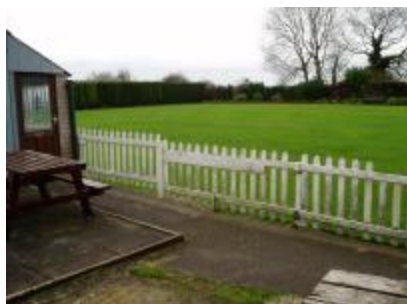
Location Ref: 021

Defect: Several level changes with generally uneven surface in between.

Inspection Notes:  
Seating & viewing area adjacent to Bowling pavillion.

Work Required: Level out floor to seating area.

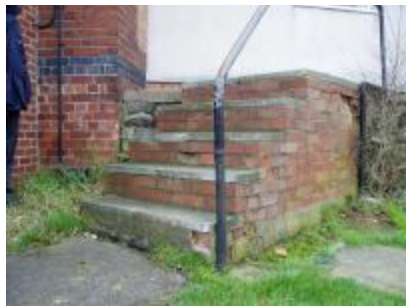
Location Ref: 022

Defect: Single loose handrail at 690mm height. No contrasting nosing, steep angle to steps.

Steps from Bowling pavillion leading back to main building. Average rise of steps is 230mm, average going of steps is 300mm.

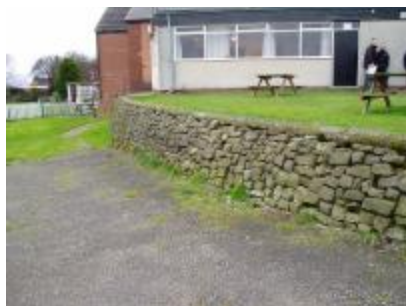
Location Ref: 023

Defect: No edge protection to end of path at corner of building.

Walkway to edge of building from rear doors to steps leading to bowling pavillion, present immediate health and safety risk from slips, trips and falls.

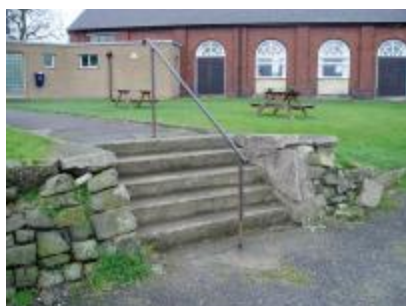
Location Ref: 024

Defect: No contrasting nosing.

Steps to main building in middle of rear beer garden. Average riser of 170mm and average going of 250mm. Handrail is central mounted at a height of 850mm.

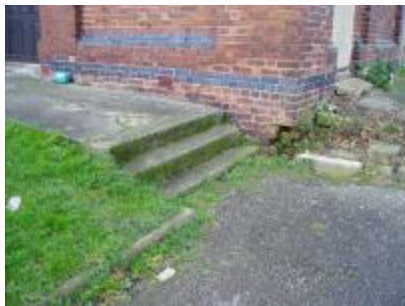
Location Ref: 025

Defect: No contrasting nosing, no handrail. Poor surface quality.

Steps to main building adjacent to Function hall. Average riser of 170mm and average going of 250mm.

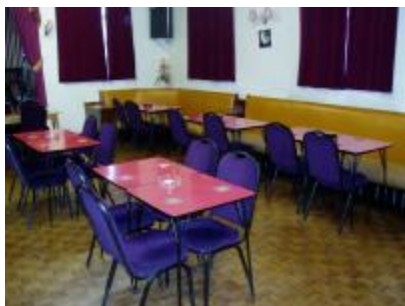
Location Ref: 026

Defect: No arm rests to chairs.

General observations: 430mm seat heights, 700mm to undersides of tables. Colour contrasts OK.

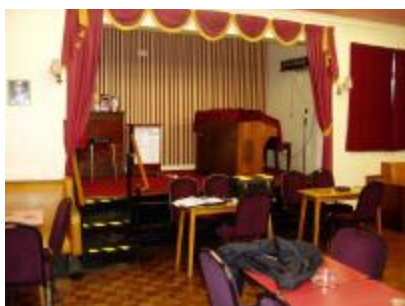
Location Ref: 027

Defect: Loose handrail to steps. Handrails at differing heights. No access to stage by wheelchair users. Difficult access to stage for ambulant disabled.

Steps up to stage. Average riser height is 220mm, average going is 230mm. No access to stage for wheelchair users. Yellow tape used as contrasting nosing. Nature and design of building restrict options for access to stage, so manage accordingly.

Work Required: Repair right hand side handrail.

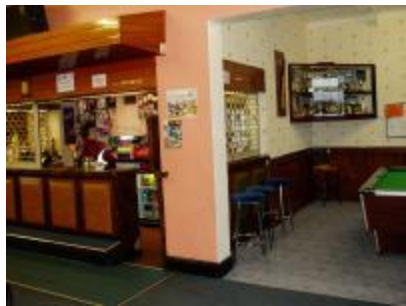
Location Ref: 028

Defect: No low level counter top to servery/bar.

Inspection Notes:  
Bar height is 1070mm

Work Required: Install dropped counter to area of servery. Brief staff on service to wheelchair users at tables during interim.

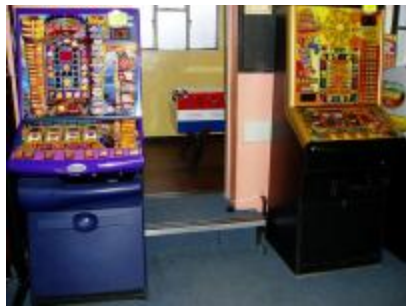
Location Ref: 029

Defect: High step over threshold to games room from bar. 200mm high and 740mm wide. opening width is 740mm.

Inspection Notes:  
Room is ideally suited to be used as an accessible toilet. Boxing to step at threshold conceals heating pipes.

Work Required: Consider conversion of games room to accessible toilet. Alternatively consider rerouting pipework in order to remove step at threshold.

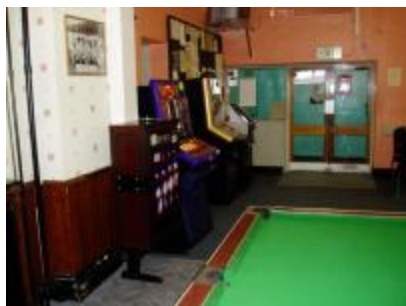
Location Ref: 030

Defect: Slot machines adjacent to pool table, coin slots between 1250mm and 1550mm.

Inspection Notes:  
Slot machine coin slots are not within easy reach for wheelchair users. Cigarette machine is just accessible by a wheelchair user at 1250mm high; other machines inaccessible.

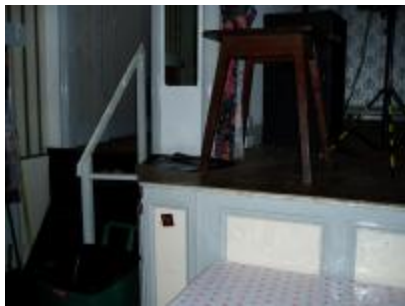
Location Ref: 032

Defect: Single handrail at 950mm does not extend beyond steps, handrail is loose. Steep steps with rising of 235mm average and going of 160mm average.

**Inspection Notes:**  
Consider hiring portable wheelchair lift during interim period. Nature and design of building restrict options for access to stage, so manage accordingly.

Priority: A - Urgent

Work Required: Repair existing handrail and install second handrail. Consider possibility of obtaining portable wheelchair lift for disabled access to stage.

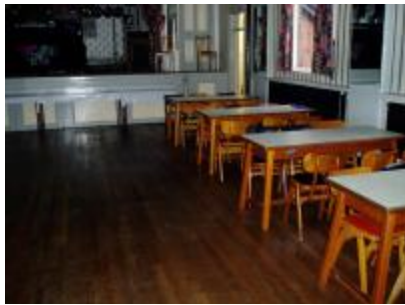
Location Ref: 033

Defect: No arm rests to chairs and insufficient leg room for wheelchair users at main tables.

**Inspection Notes:**  
Seating height 455mm, 620mm to underside of main tables, 720mm to underside of serving tables.

Priority: A - Urgent

Work Required: Obtain suitable seating. Suggest use of serving tables for wheelchair users at public events.

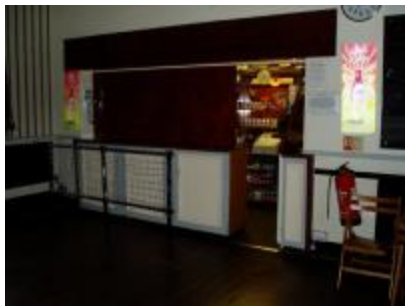
Location Ref: 034

Defect: No low level counter top to servery. Bar height of 1070mm.

Inspection Notes:  
Queue dividing rail is useful to provide leaning support.

Work Required:  
Drop counter at refit. Manage bar service in interim.

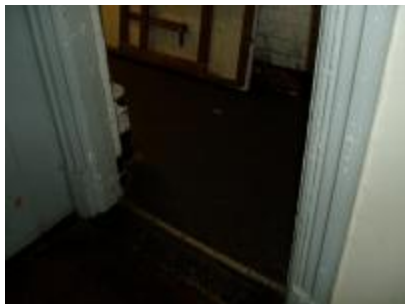
Location Ref: 035

Defect: Raised threshold of 40mm to door.

Inspection Notes:  
760mm door width, 1000mm corridor width, door handle height 1060mm. As this is a fire exit route there should be no items stored in this area.

Work Required:  
Remove threshold from doorway.

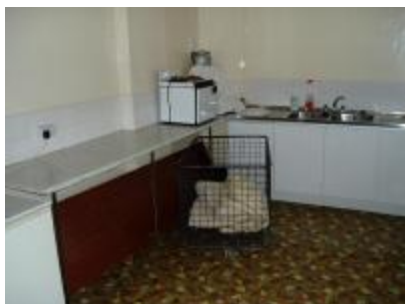
Location Ref: 036

Defect: Taps pose difficulty to turn for mobility impaired. No contrast between sockets/switches and walls.

Inspection Notes:  
Surface height is 825mm.

Work Required:  
Consider replacing fittings. Provide contrast to sockets/switches.

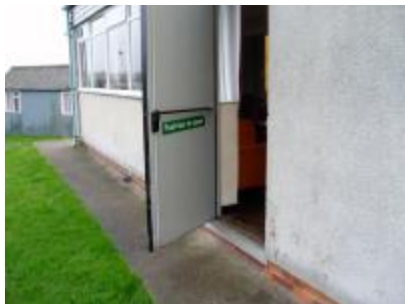
Location Ref: 038

Defect: Unclear signage, heavy door openings, no ramped egress.

General fire escape information: Average door opening width of 870mm, 170mm step height average, 20mm threshold average. Strongly recommend client to undertake a Fire Risk Assessment.

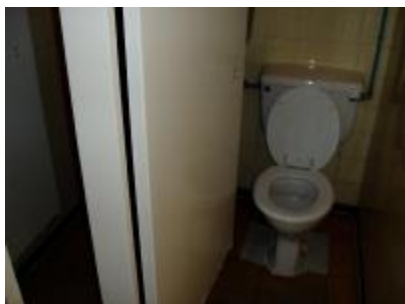
Location Ref: 039

Defect: 30mm between opened cubicle door and toilet seat. Difficulty in closing/opening bolt on cubicle door. No support rails. Hand drier height of 1500mm.

Door opening force of 20 newtons. No wheelchair accessible toilet facilities.

Work Required: Install support rail by stall. Change colour of floor tiles at next refit to aid distinction between floor and latrine trough. Lower hand drier. Replace door bolts.

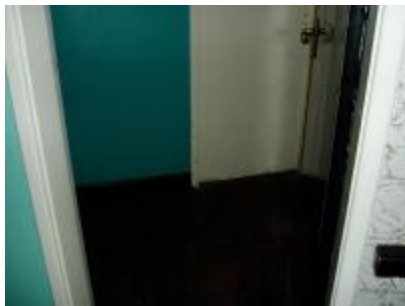
Location Ref: 040

Defect: Limited width of door opening. No wheelchair accessible toilet throughout building.

Inspection Notes:  
Fibreboard partition wall to games room.

Work Required: Suggest to convert games room to accessible toilet (accessed from Gents WC lobby) and change door width.

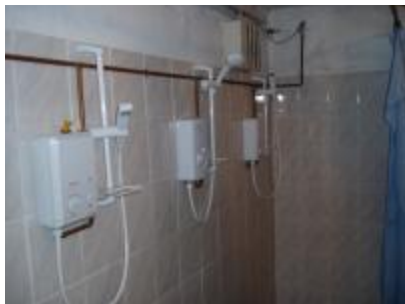
Location Ref: 041

Defect: No handrails to shower area.

Inspection Notes:  
Shower room used by football/cricket teams, in addition to external changing facilities.

Work Required: Install handrails adjacent to showers and over bund wall.

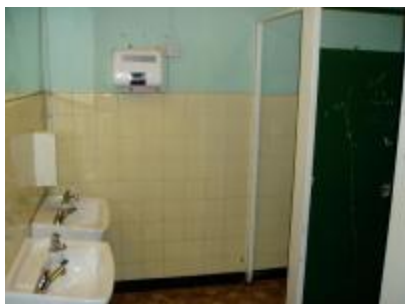
Location Ref: 042

Defect: Difficulty in closing/opening bolt on cubicle door. No support rails. Hand drier height of 1500mm.

Inspection Notes:  
Door opening force of 20 newtons. No wheelchair accessible toilet facilities.

Work Required: Lower hand drier. Replace door bolts.
